# Access Compliance Report

## Public Rights-of-Way

### (Curb Ramps)

Intersection ID: 17113	Main Street: STERLING_RD	Cross Street: WESTFIELD_RD	Location: SW
ADA ID: 48A7E7649BFB	Ramp Type: Perp	Initial Pass/Fail: Fail	Overall Compliance: No
Severity Score: 25			
Codes/Mitigation Info/Possible Solution		Field Measurements/Component Compliance

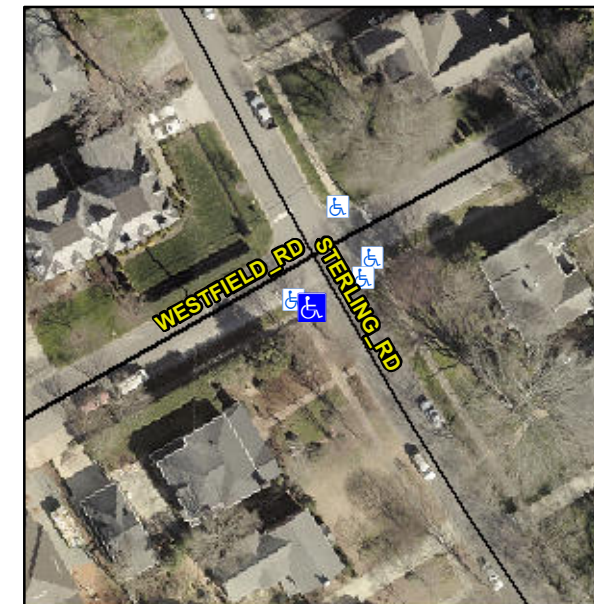
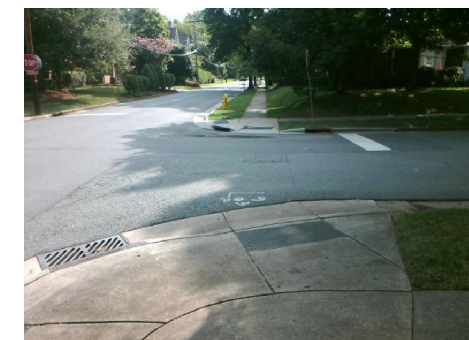
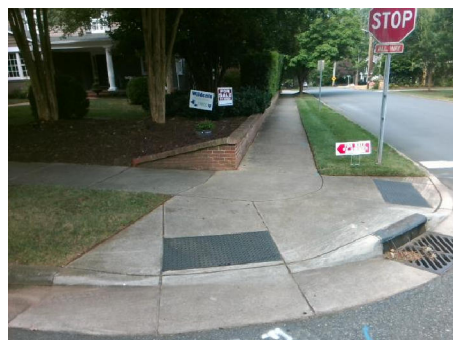
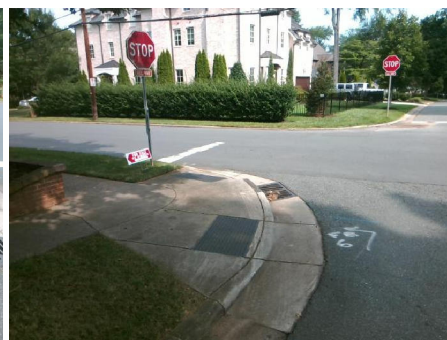
Compliance	Description	Data	Compliance	Description	Data
N/A	Ramp Length (in)	61.5	No	Ramp Slope (%)	9.2
Yes	Ramp Width (in)	48.0	No	Ramp XSlope (%)	6.9
N/A	Flare Type LT	N/A	N/A	Flare Type RT	N/A
N/A	Flare Slope LT (%)	N/A	N/A	Flare Slope RT (%)	N/A
N/A	Flare Traversable LT?	N/A	N/A	Flare Traversable RT?	N/A
N/A	Landing Length (in)	N/A	N/A	DWS Provided?	N/A
N/A	Landing Width (in)	N/A	N/A	DWS Contrast?	N/A
N/A	Landing Slope (%)	N/A	N/A	DWS Length (in)	N/A
N/A	Landing X Slope (%)	N/A	N/A	DWS Full Width?	N/A
N/A	Landing Curb? (Y/N)	N/A	N/A	DWS Offset (in)	N/A
N/A	Shared Landing?	N/A			
N/A	Gutter Ponding?	N/A	N/A	Gutter Slope (%)	N/A
N/A	Gutter Lip Ht (in)	N/A	N/A	Gutter X Slope (%)	N/A
N/A	Painted X Walk1?	No	N/A	Painted X Walk2?	N/A
	X Walk 1 Direction	To NE		X Walk 2 Direction	N/A
N/A	X Walk 1 Width (in)	N/A	N/A	X Walk 2 Width (in)	N/A
	X Walk 1 Slope (%)	2.6		X Walk 2 Slope (%)	N/A
	X Walk 1 X Slope (%)	2.3		X Walk 2 X Slope (%)	N/A

N/A	Ramp inside XWalk1?	N/A	N/A	Ramp inside XWalk2?	N/A
	Road Slope (%)	N/A	N/A	Clear Space?	N/A
	Road X Slope (%)	N/A	N/A	Clear Space to XWalk (in)	N/A
N/A	Any Obstructions?	N/A	N/A	Storm Grate/Utility Hazard?	N/A
	Obstruction Type			Storm Grate/Utility Type	
		N/A			N/A
			Yes	Surface Condition? (G/P)	Good

**Remove & Replace Entire Ramp.**

**R304.2.2, R304.5.3**
