# Access Compliance Report

## Public Rights-of-Way

### (Curb Ramps)

Intersection ID: 30278	Main Street: BLACK_KETTLE_DR	Cross Street: OLD_IRONSIDE_DR	Location: SE
ADA ID: 48AFD249DFED	Ramp Type: PerpDiag	Initial Pass/Fail: Fail	Overall Compliance: No
		Severity Score: 10

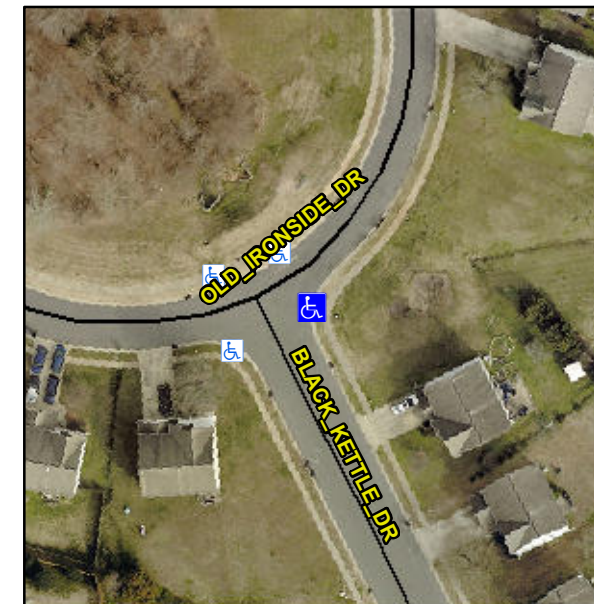
**Not Found, R304.5.1, R304.5.3**

Compliance	Description	Data	Compliance	Description	Data
N/A	Ramp Length (in)	48.0	Yes	Ramp Slope (%)	5.2
No	Ramp Width (in)	45.0	No	Ramp XSlope (%)	3.4
N/A	Flare Type LT	N/A	N/A	Flare Type RT	N/A
N/A	Flare Slope LT (%)	N/A	N/A	Flare Slope RT (%)	N/A
N/A	Flare Traversable LT?	N/A	N/A	Flare Traversable RT?	N/A
N/A	Landing Length (in)	N/A	N/A	DWS Provided?	N/A
N/A	Landing Width (in)	N/A	N/A	DWS Contrast?	N/A
N/A	Landing Slope (%)	N/A	N/A	DWS Length (in)	N/A
N/A	Landing X Slope (%)	N/A	N/A	DWS Full Width?	N/A
N/A	Landing Curb? (Y/N)	N/A	N/A	DWS Offset (in)	N/A
N/A	Shared Landing?	N/A			
N/A	Gutter Ponding?	N/A	N/A	Gutter Slope (%)	N/A
N/A	Gutter Lip Ht (in)	N/A	N/A	Gutter X Slope (%)	N/A
N/A	Painted X Walk1?	No	N/A	Painted X Walk2?	No
	X Walk 1 Direction	To N		X Walk 2 Direction	To W
N/A	X Walk 1 Width (in)	N/A	N/A	X Walk 2 Width (in)	N/A
	X Walk 1 Slope (%)	1.6		X Walk 2 Slope (%)	3.4
	X Walk 1 X Slope (%)	4.2		X Walk 2 X Slope (%)	2.6

N/A	Ramp inside XWalk1?	N/A	N/A	Ramp inside XWalk2?	N/A
	Road Slope (%)	4.6	N/A	Clear Space?	N/A
	Road X Slope (%)	2.8	N/A	Clear Space to XWalk (in)	N/A
N/A	Any Obstructions?	N/A	N/A	Storm Grate/Utility Hazard?	N/A
	Obstruction Type			Storm Grate/Utility Type	
		N/A			N/A
			Yes	Surface Condition? (G/P)	Good

**Remove & Replace Curb Ramp With Two New Directional Ramps or Equivalent.**
