Access Compliance Report

Public Rights-of-Way

(Curb Ramps)

| Intersection ID: 50867 | Main Street: REAMES_RD | Cross Street: BROOKLINE_RIDGE_DR | Location: S |

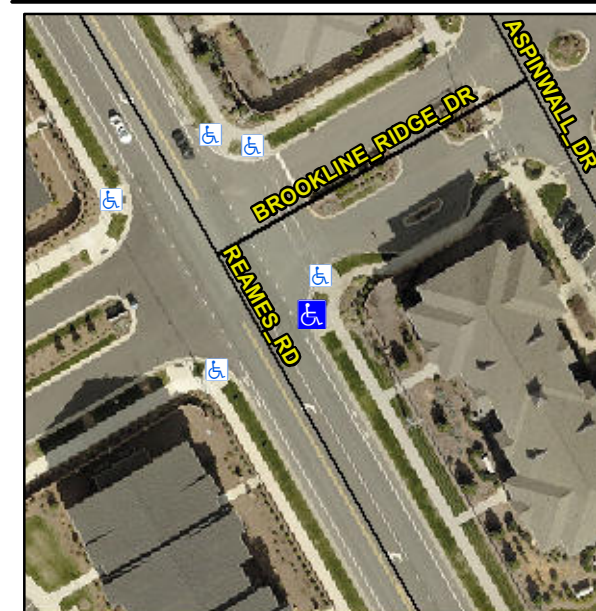
| ADA ID: 48BEEBE95A25 | Ramp Type: Perp | Initial Pass/Fail: Fail | Overall Compliance: No |
| Severity Score: 8.75 | | | |

Not Found, R304.5.1

| Compliance | Description | Data | Compliance | Description | Data |
|---|---|---|---|---|---|
| No | Ramp Width (in) | 47.0 | Yes | Ramp XSlope (%) | 1.5 |

Possible Solutions:

Remove & Replace Entire Ramp.

Total Cost: \$ 1850.00
