Access Compliance Report

Public Rights-of-Way

(Curb Ramps)

Intersection ID: N/A	Main Street: BALLANTYNE COMMONS PKWY	Cross Street: N/A	Location: SW
ADA ID: 48C0C962D91A	Ramp Type: PerpDiag	Initial Pass/Fail: Fail	Overall Compliance: No
		Severity Score: 10

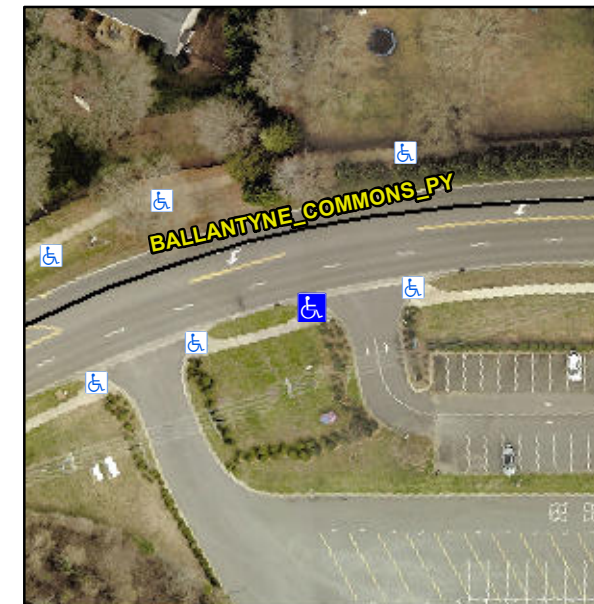
Not Found, R304.5.1, R304.5.3

Compliance	Description	Data	Compliance	Description	Data
N/A	Ramp Length (in)	105.0	Yes	Ramp Slope (%)	6.3
No	Ramp Width (in)	42.5	No	Ramp XSlope (%)	3.8
N/A	Flare Type LT	N/A	N/A	Flare Type RT	N/A
N/A	Flare Slope LT (%)	N/A	N/A	Flare Slope RT (%)	N/A
N/A	Flare Traversable LT?	N/A	N/A	Flare Traversable RT?	N/A
N/A	Landing Length (in)	N/A	N/A	DWS Provided?	N/A
N/A	Landing Width (in)	N/A	N/A	DWS Contrast?	N/A
N/A	Landing Slope (%)	N/A	N/A	DWS Length (in)	N/A
N/A	Landing X Slope (%)	N/A	N/A	DWS Full Width?	N/A
N/A	Landing Curb? (Y/N)	N/A	N/A	DWS Offset (in)	N/A
N/A	Shared Landing?	N/A			
N/A	Gutter Ponding?	N/A	N/A	Gutter Slope (%)	N/A
N/A	Gutter Lip Ht (in)	N/A	N/A	Gutter X Slope (%)	N/A
N/A	Painted X Walk1?	No	N/A	Painted X Walk2?	No
	X Walk 1 Direction	To E		X Walk 2 Direction	To N
N/A	X Walk 1 Width (in)	N/A	N/A	X Walk 2 Width (in)	N/A
	X Walk 1 Slope (%)	3.7		X Walk 2 Slope (%)	3.9
	X Walk 1 X Slope (%)	0.4		X Walk 2 X Slope (%)	1.7

N/A	Ramp inside XWalk1?	N/A	N/A	Ramp inside XWalk2?	N/A
	Road Slope (%)	0.9	N/A	Clear Space?	N/A
	Road X Slope (%)	2.8	N/A	Clear Space to XWalk (in)	N/A
N/A	Any Obstructions?	N/A	N/A	Storm Grate/Utility Hazard?	N/A
	Obstruction Type			Storm Grate/Utility Type	
		N/A			N/A
			Yes	Surface Condition? (G/P)	Good

Remove & Replace Curb Ramp With Two New Directional Ramps or Equivalent.

Total Cost: \$ 3200.00
