Access Compliance Report

Public Rights-of-Way

(Curb Ramps)

Intersection ID: 9172	Main Street: E_CRAIGHEAD_RD	Cross Street: N_TRYON_ST	Location: SE
ADA ID: 48C7097F4AAA	Ramp Type: Perp	Initial Pass/Fail: Fail	Overall Compliance: No
Severity Score: 10			
Codes/Mitigation Info/Possible Solution		Field Measurements/Component Compliance

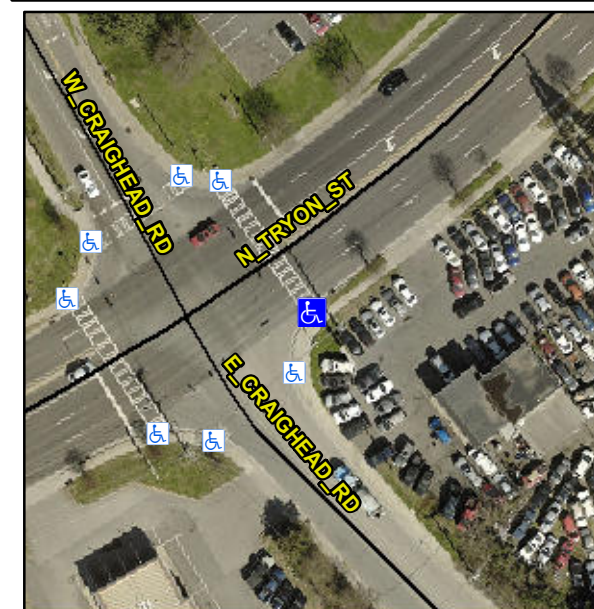
Not Found, R304.5.1, R304.5.3

Compliance	Description	Data	Compliance	Description	Data
N/A	Ramp Length (in)	106.5	Yes	Ramp Slope (%)	6.3
No	Ramp Width (in)	40.0	No	Ramp XSlope (%)	2.3
N/A	Flare Type LT	N/A	N/A	Flare Type RT	N/A
N/A	Flare Slope LT (%)	N/A	N/A	Flare Slope RT (%)	N/A
N/A	Flare Traversable LT?	N/A	N/A	Flare Traversable RT?	N/A
N/A	Landing Length (in)	N/A	N/A	DWS Provided?	N/A
N/A	Landing Width (in)	N/A	N/A	DWS Contrast?	N/A
N/A	Landing Slope (%)	N/A	N/A	DWS Length (in)	N/A
N/A	Landing X Slope (%)	N/A	N/A	DWS Full Width?	N/A
N/A	Landing Curb? (Y/N)	N/A	N/A	DWS Offset (in)	N/A
N/A	Shared Landing?	N/A			
N/A	Gutter Ponding?	N/A	N/A	Gutter Slope (%)	N/A
N/A	Gutter Lip Ht (in)	N/A	N/A	Gutter X Slope (%)	N/A
N/A	Painted X Walk1?	Yes	N/A	Painted X Walk2?	N/A
	X Walk 1 Direction	To N		X Walk 2 Direction	N/A
N/A	X Walk 1 Width (in)	88.0	N/A	X Walk 2 Width (in)	N/A
	X Walk 1 Slope (%)	2.4		X Walk 2 Slope (%)	N/A
	X Walk 1 X Slope (%)	1.2		X Walk 2 X Slope (%)	N/A

N/A	Ramp inside XWalk1?	Yes	N/A	Ramp inside XWalk2?	N/A
	Road Slope (%)	N/A	N/A	Clear Space?	N/A
	Road X Slope (%)	N/A	N/A	Clear Space to XWalk (in)	N/A
N/A	Any Obstructions?	N/A	N/A	Storm Grate/Utility Hazard?	N/A
	Obstruction Type			Storm Grate/Utility Type	
		N/A			N/A
		Yes		Surface Condition? (G/P)	Good

Possible Solutions:

Remove & Replace Entire Ramp.
