# Access Compliance Report

## Public Rights-of-Way (Curb Ramps)

Intersection ID: 2529	Main Street: BAFFIN_CT	Cross Street: BENTGRASS_RUN_DR	Location:	N
ADA ID: 48CC830B5F02	Ramp Type: PerpDiag	Initial Pass/Fail: Fail	Overall Compliance: No	Severity Score: 46.25
Codes/Mitigation Info/Possible Solution		Field Measurements/Component Compliance

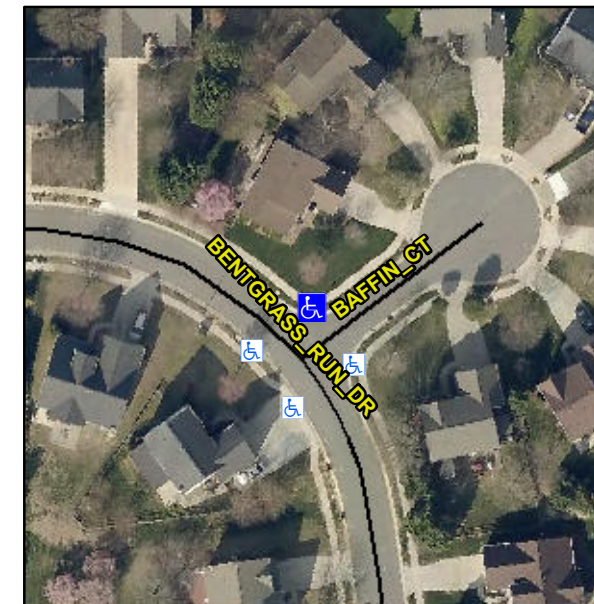
**Not Found, R304.5.1, R304.2.2, R304.5.3**

Compliance	Description	Data	Compliance	Description	Data
N/A	Ramp Length (in)	37.0	No	Ramp Slope (%)	8.4
No	Ramp Width (in)	39.0	No	Ramp XSlope (%)	8.8
N/A	Flare Type LT	N/A	N/A	Flare Type RT	N/A
N/A	Flare Slope LT (%)	N/A	N/A	Flare Slope RT (%)	N/A
N/A	Flare Traversable LT?	N/A	N/A	Flare Traversable RT?	N/A
N/A	Landing Length (in)	N/A	N/A	DWS Provided?	N/A
N/A	Landing Width (in)	N/A	N/A	DWS Contrast?	N/A
N/A	Landing Slope (%)	N/A	N/A	DWS Length (in)	N/A
N/A	Landing X Slope (%)	N/A	N/A	DWS Full Width?	N/A
N/A	Landing Curb? (Y/N)	N/A	N/A	DWS Offset (in)	N/A
N/A	Shared Landing?	N/A			
N/A	Gutter Ponding?	N/A	N/A	Gutter Slope (%)	N/A
N/A	Gutter Lip Ht (in)	N/A	N/A	Gutter X Slope (%)	N/A
N/A	Painted X Walk1?	No	N/A	Painted X Walk2?	No
	X Walk 1 Direction	To SW		X Walk 2 Direction	To SE
N/A	X Walk 1 Width (in)	N/A	N/A	X Walk 2 Width (in)	N/A
	X Walk 1 Slope (%)	7.5		X Walk 2 Slope (%)	2.4
	X Walk 1 X Slope (%)	4.3		X Walk 2 X Slope (%)	5.4

N/A	Ramp inside XWalk1?	N/A	N/A	Ramp inside XWalk2?	N/A
	Road Slope (%)	8.1	N/A	Clear Space?	N/A
	Road X Slope (%)	2.0	N/A	Clear Space to XWalk (in)	N/A
N/A	Any Obstructions?	N/A	N/A	Storm Grate/Utility Hazard?	N/A
	Obstruction Type			Storm Grate/Utility Type	
		N/A			N/A
			Yes	Surface Condition? (G/P)	Good

**Remove & Replace Curb Ramp With Two New Directional Ramps or Equivalent.**
