# Access Compliance Report

## Public Rights-of-Way

| Intersection ID: 43079 | Main Street: SUMTER_AV | Cross Street: WALNUT_AV | Location: | N |
| ADA ID: 48D69204D6FC | Ramp Type: PerpDiag | Initial Pass/Fail: Fail | Overall Compliance: No | Severity Score: 67.5 |

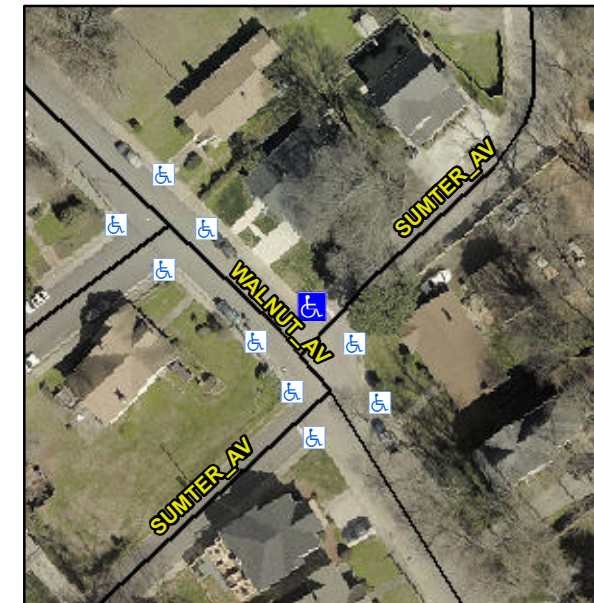
**Not Found, R304.5.1, R304.2.2, R304.5.3**

| Compliance | Description | Data | Compliance | Description | Data |
|---|---|---|---|---|---|
| N/A | Ramp Length (in) | 43.0 | No | Ramp Slope (%) | 13.9 |
| No | Ramp Width (in) | 34.0 | No | Ramp XSlope (%) | 7.0 |

**Remove & Replace Curb Ramp With Two New Directional Ramps or Equivalent.**
