Access Compliance Report

Public Rights-of-Way

| Intersection ID: 51059 | Main Street: CORY-BRET_LN | Cross Street: CRAIGMOSS_LN | Location: SE |
| ADA ID: 48E0FBE43453 | Ramp Type: Perp | Initial Pass/Fail: Fail | Overall Compliance: No |

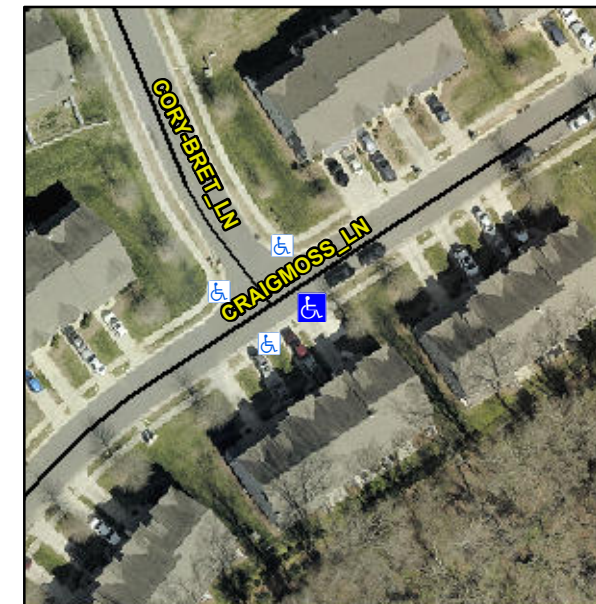
| Severity Score: 12.5 | | | |

Not Found, R304.2.2

| Compliance | Description | Data | Compliance | Description | Data |
|---|---|---|---|---|---|
| N/A | Ramp Length (in) | 48.0 | No | Ramp Slope (%) | 8.4 |

Remove & Replace Entire Ramp.
