Access Compliance Report Public Rights-of-Way (Curb Ramps)

Intersection ID: 49255 Main Str	Main Street: HOPKINS_ST		reet:	OAKBURN_DR	Location:	SE									
ADA ID: 48F2B8E9E298 Ramp T	ID: 48F2B8E9E298 Ramp Type: PerpDiag		ss/Fa	nil: Fail Overall O	o Severity Score:	58.75									
Codes/Mitigation Info/Possible Solution			Field Measurements/Component Compliance												
CATERINAL DR	Possible Solutions:		Compliance Description			Data Compliance Description		Data							
	Remove & Replace Curb Ramp W	vith I	N/A	Ramp Length (in)	47.0	No	Ramp Slope (%)	17.2							
	Two New Directional Ramps or Equivalent.	I	No	Ramp Width (in)	46.0	No	Ramp XSlope (%)	7.6							
		I	N/A	Flare Type LT	N/A	N/A	Flare Type RT	N/A							
		I	N/A	Flare Slope LT (%)	N/A	N/A	Flare Slope RT (%)	N/A							
		I	N/A	Flare Traversable LT?	N/A	N/A	Flare Traversable RT?	N/A							
	1	I	N/A	Landing Length (in)	N/A	N/A	DWS Provided?	N/A							
	Surveyor Notes:	I	N/A	Landing Width (in)	N/A	N/A	DWS Contrast?	N/A

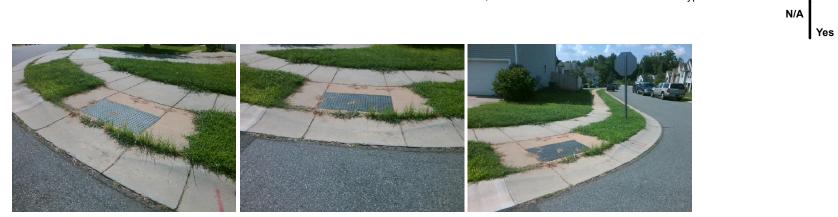
N/A	I	N/A	Landing Slope (%)	N/A	N/A	DWS Length (in)	N/A							
		I	N/A	Landing X Slope (%)	N/A	N/A	DWS Full Width?	N/A							
		1	N/A	Landing Curb? (Y/N)	N/A	N/A	DWS Offset (in)	N/A							
		I	N/A	Shared Landing?	N/A										
	PROW/ADA:	I	N/A	Gutter Ponding?	N/A	N/A	Gutter Slope (%)	N/A							
	Not Found, R304.5.1, R304.2.2,	1	N/A	Gutter Lip Ht (in)	N/A	N/A	Gutter X Slope (%)	N/A							
	R304.5.3	1	N/A	Painted X Walk1?	No	N/A	Painted X Walk2?	No							
				X Walk 1 Direction	To N		X Walk 2 Direction	To W							
		I	N/A	X Walk 1 Width (in)	N/A	N/A	X Walk 2 Width (in)	N/A							
Street 1 Name OAKBURN DR				X Walk 1 Slope (%)	3.6		X Walk 2 Slope (%)	4.0							
Stop Condition-Street 2 None				X Walk 1 X Slope (%)	3.9		X Walk 2 X Slope (%)	10.1							
Street 2 Name HOPKINS ST		1	N/A	Ramp inside XWalk1?	N/A	N/A	Ramp inside XWalk2?	N/A							
Stop Condition-Street 1 StopSign				Road Slope (%)	8.8	N/A	Clear Space?	N/A

Road X Slope (%)	1.4	N/A	Clear Space to XWalk (in)	N/A							
		I	N/A	Any Obstructions?	N/A	N/A	Storm Grate/Utility Hazard?	N/A							
	Total Cost: \$ 32	200.00		Obstruction Type			Storm Grate/Utility Type								
					N/A			N/A
