Access Compliance Report Public Rights-of-Way (Curb Ramps)

•		-					
Intersection ID: 50541	Main Street: CAYENNE_DR			Street:	LEMONGRASS_LN	Location:	NW		
ADA ID: 48FC061802B3	Ramp Type: PerpDiag			Initial Pass/Fail: Fail Overall Compliance: No				o Severity Score:	21.25
Codes/Mitigation Info/Possible Solution				Field Measurements/Component Compliance					
		Possible Solutions:					Data Compliance Description		Data
		Remove & Replace Curb Ramp V	Vith	N/A	Ramp Length (in)	48.0	No	Ramp Slope (%)	9.0
		Two New Directional Ramps or		No	Ramp Width (in)	43.0	Yes	Ramp XSlope (%)	1.1
		Equivalent.		N/A	Flare Type LT	N/A	N/A	Flare Type RT	N/A
				N/A	Flare Slope LT (%)	N/A	N/A	Flare Slope RT (%)	N/A
				N/A	Flare Traversable LT?	N/A	N/A	Flare Traversable RT?	N/A
				N/A	Landing Length (in)	N/A	N/A	DWS Provided?	N/A
TIONERASE		Surveyor Notes:		N/A	Landing Width (in)	N/A	N/A	DWS Contrast?	N/A
		NA		N/A	Landing Slope (%)	N/A	N/A	DWS Length (in)	N/A
		1071		N/A	Landing X Slope (%)	N/A	N/A	DWS Full Width?	N/A

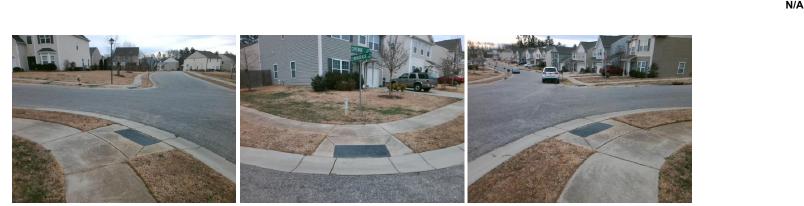
Line to the second seco				N/A	Landing Curb? (Y/N)	N/A	N/A	DWS Offset (in)	N/A
				N/A	Shared Landing?	N/A			
· · · · · · · · · · · · · · · · · · ·		PROW/ADA:		N/A	Gutter Ponding?	N/A	N/A	Gutter Slope (%)	N/A
	N 1 1 2	Not Found, R304.5.1, R304.2.2		N/A	Gutter Lip Ht (in)	N/A	N/A	Gutter X Slope (%)	N/A
SI I C	1115 01			N/A	Painted X Walk1?	No	N/A	Painted X Walk2?	No
					X Walk 1 Direction	To S		X Walk 2 Direction	To E
		4		N/A	X Walk 1 Width (in)	N/A	N/A	X Walk 2 Width (in)	N/A
Street 1 Name	LEMONGRASS LN	-			X Walk 1 Slope (%)	4.1		X Walk 2 Slope (%)	2.0
Stop Condition-Street 2	StopSign				X Walk 1 X Slope (%)	0.3		X Walk 2 X Slope (%)	4.5
Street 2 Name	CAYENNE DR			N/A	Ramp inside XWalk1?	N/A	N/A	Ramp inside XWalk2?	N/A
Stop Condition-Street 1	None				Road Slope (%)	2.6	N/A	Clear Space?	N/A
,					Road X Slope (%)	4.3	N/A	Clear Space to XWalk (in)	N/A
				N/A	Any Obstructions?	N/A	N/A	Storm Grate/Utility Hazard?	N/A

Yes Surface Condition? (G/P)

Good

Total Cost: \$ 3	200.00		Obstruction Type			Storm Grate/Utility Type	
		- •• •				N/A			N/A
