# Access Compliance Report

## Public Rights-of-Way

### (Curb Ramps)

Intersection ID: 31553	Main Street: CALDWELL_RD	Cross Street: CALDWELL_RIDGE_PY	Location:	E
ADA ID: 4909F64B51C5	Ramp Type: Combination1	Initial Pass/Fail: Fail	Overall Compliance: No	Severity Score: 10

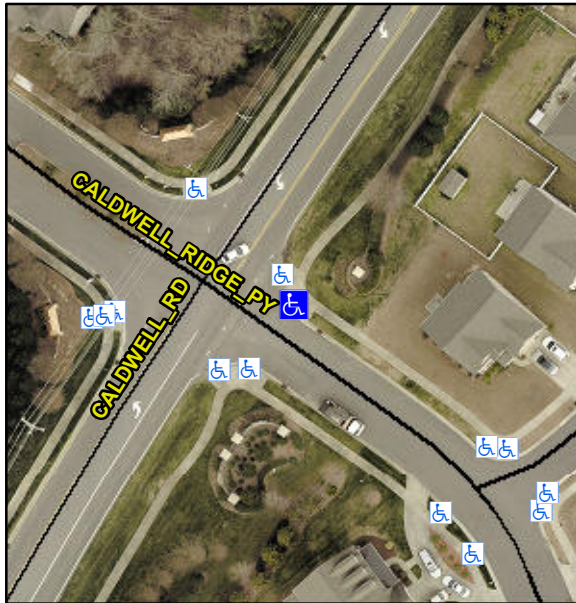
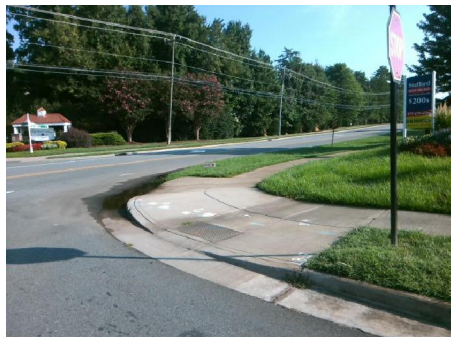
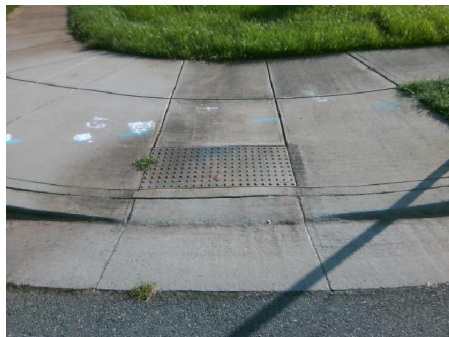
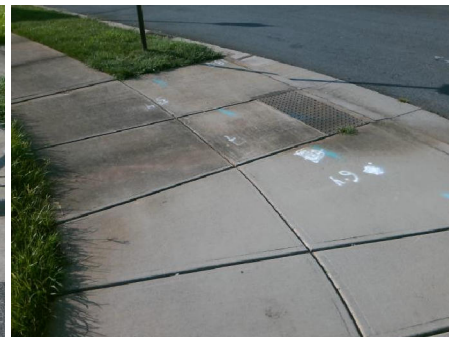
**LT RP < 5%**

**Not Found, R304.5.1, R304.5.3**

Compliance	Description	Data	Compliance	Description	Data
N/A	Ramp Length LT (in)	24.0	N/A	Ramp Length RT (in)	48.0
Yes	Ramp Width LT (in)	59.0	Yes	Ramp Width RT (in)	59.0
Yes	Ramp Slope LT (%)	2.1	Yes	Ramp Slope RT (%)	5.0
No	Ramp XSlope LT (%)	2.5	Yes	Ramp XSlope RT (%)	1.8
N/A	Ramp Length (in)	71.5	Yes	Ramp Slope (%)	1.9
No	Ramp Width (in)	47.5	No	Ramp XSlope (%)	2.8
N/A	Flare Type LT	N/A	N/A	Flare Type RT	N/A
N/A	Flare Slope LT (%)	N/A	N/A	Flare Slope RT (%)	N/A
N/A	Flare Traversable LT?	N/A	N/A	Flare Traversable RT?	N/A
N/A	Landing Length (in)	N/A	N/A	DWS Provided?	N/A
N/A	Landing Width (in)	N/A	N/A	DWS Contrast?	N/A
N/A	Landing Slope (%)	N/A	N/A	DWS Length (in)	N/A
N/A	Landing X Slope (%)	N/A	N/A	DWS Full Width?	N/A
N/A	Landing Curb? (Y/N)	N/A	N/A	DWS Offset (in)	N/A
N/A	Shared Landing?	N/A			
N/A	Gutter Ponding?	N/A	N/A	Gutter Slope (%)	N/A
N/A	Gutter Lip Ht (in)	N/A	N/A	Gutter X Slope (%)	N/A
N/A	Painted X Walk1?	No	N/A	Painted X Walk2?	N/A

Possible Solutions:

**Remove & Replace Entire Ramp.**
