# Access Compliance Report

## Public Rights-of-Way

### (Curb Ramps)

Intersection ID: 12164	Main Street: SEIGLE_AV	Cross Street: BELMONT_AV	Location:	N
ADA ID: 490C36997682	Ramp Type: BlendTrans2	Initial Pass/Fail: Fail	Overall Compliance: No	Severity Score: 10
Codes/Mitigation Info/Possible Solution		Field Measurements/Component Compliance

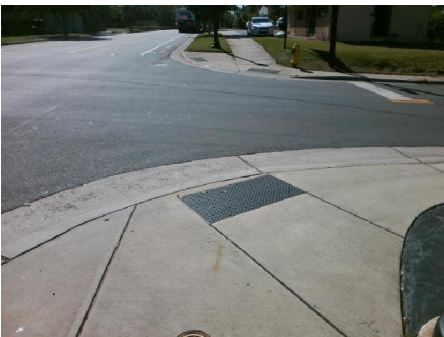
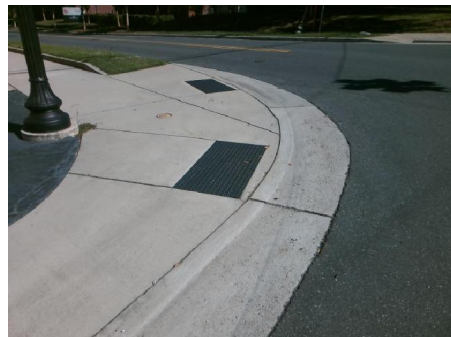
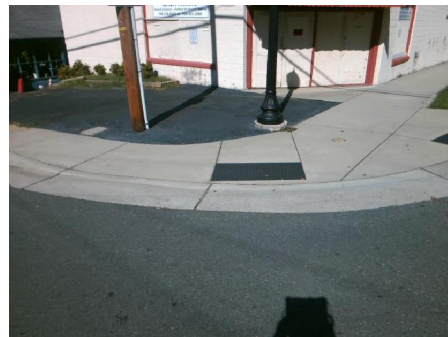
**Not Found, R304.5.1, R304.5.3**

Compliance	Description	Data	Compliance	Description	Data
N/A	Ramp Length (in)	71.0	Yes	BlendTrans Slope (%)	0.6
No	Ramp Width (in)	47.5	No	BlendTrans XSlope (%)	4.1
N/A	Flare Type LT	N/A	N/A	Flare Type RT	N/A
N/A	Flare Slope LT (%)	N/A	N/A	Flare Slope RT (%)	N/A
N/A	Flare Traversable LT?	N/A	N/A	Flare Traversable RT?	N/A
N/A	Landing Length (in)	N/A	N/A	DWS Provided?	N/A
N/A	Landing Width (in)	N/A	N/A	DWS Contrast?	N/A
N/A	Landing Slope (%)	N/A	N/A	DWS Length (in)	N/A
N/A	Landing X Slope (%)	N/A	N/A	DWS Full Width?	N/A
N/A	Landing Curb? (Y/N)	N/A	N/A	DWS Offset (in)	N/A
N/A	Shared Landing?	N/A			
N/A	Gutter Ponding?	N/A	N/A	Gutter Slope (%)	N/A
N/A	Gutter Lip Ht (in)	N/A	N/A	Gutter X Slope (%)	N/A
N/A	Painted X Walk1?	No	N/A	Painted X Walk2?	N/A
	X Walk 1 Direction	To SW		X Walk 2 Direction	N/A
	X Walk 1 Width (in)	N/A		X Walk 2 Width (in)	N/A
	X Walk 1 Slope (%)	3.4		X Walk 2 Slope (%)	N/A
	X Walk 1 X Slope (%)	9.1		X Walk 2 X Slope (%)	N/A

N/A	Ramp inside XWalk1?	N/A	N/A	Ramp inside XWalk2?	N/A
	Road Slope (%)	9.1		Clear Space?	N/A
	Road X Slope (%)	3.4	N/A	Clear Space to XWalk (in)	N/A
N/A	Any Obstructions?	N/A	N/A	Storm Grate/Utility Hazard?	N/A
	Obstruction Type			Storm Grate/Utility Type	
		N/A			N/A
			Yes	Surface Condition? (G/P)	Good
			No	Curb Slope (%)	6.3

**Remove & Replace Curb Ramp With Two New Directional Ramps or Equivalent.**

Total Cost: \$ **3200.00**
