# Access Compliance Report

## Public Rights-of-Way

### (Curb Ramps)

Intersection ID: 17400	Main Street: BAINBRIDGE_RD	Cross Street: VISTA_DR	Location: NE
ADA ID: 4912E2BF9AC9	Ramp Type: Directional1	Initial Pass/Fail: Fail	Overall Compliance: No
Severity Score: 1.25			
Codes/Mitigation Info/Possible Solution		Field Measurements/Component Compliance

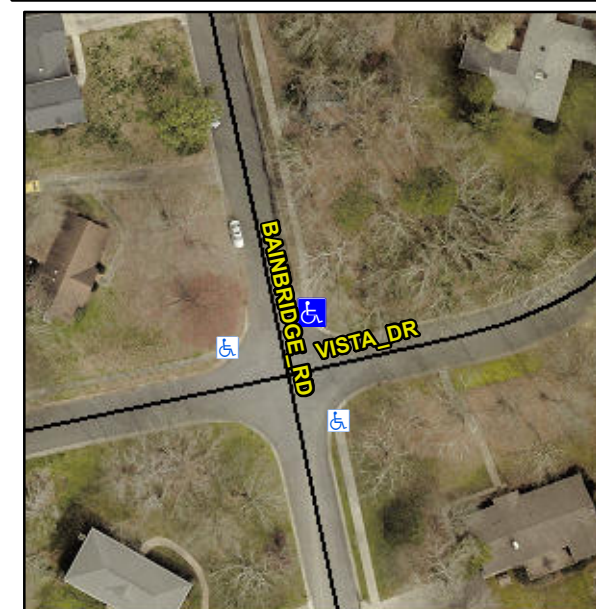
**R304.5.3**

Compliance	Description	Data	Compliance	Description	Data
N/A	Ramp Length (in)	73.0	N/A	Grade Break?	N/A
Yes	Ramp Width (in)	60.0	N/A	Grade Break Slope (%)	0.0
Yes	Ramp Slope (%)	1.3	N/A	Grade Break XSlope (%)	0.0
No	Ramp XSlope (%)	2.3			
N/A	Flare Type LT	N/A	N/A	Flare Type RT	N/A
N/A	Flare Slope LT (%)	N/A	N/A	Flare Slope RT (%)	0.0
N/A	Flare Traversable LT?	N/A	N/A	Flare Traversable RT?	N/A
N/A	Landing Length (in)	0.0	N/A	DWS Provided?	N/A
N/A	Landing Width (in)	0.0	N/A	DWS Contrast?	N/A
N/A	Landing Slope (%)	0.0	N/A	DWS Length (in)	N/A
N/A	Landing X Slope (%)	0.0	N/A	DWS Full Width?	N/A
N/A	Landing Curb? (Y/N)	N/A	N/A	DWS Offset LT (in)	N/A
N/A	Shared Landing?	N/A	N/A	DWS Offset RT (in)	N/A
N/A	Gutter Ponding?	0.0	N/A	Gutter Slope (%)	N/A
N/A	Gutter Lip Ht (in)	0.0	N/A	Gutter X Slope (%)	N/A
N/A	Painted X Walk1?	No		Road Slope (%)	2.1
	X Walk 1 Direction	To SE		Road X Slope (%)	0.3
	X Walk 1 Width (in)	N/A		Clear Space?	N/A

X Walk 1 Slope (%)	2.1	N/A	Clear Space to XWalk (in)	N/A
	X Walk 1 X Slope (%)	0.3	N/A	Storm Grate/Utility Hazard?	N/A
N/A	Ramp inside XWalk1?	N/A		Storm Grate/Utility Type	
N/A	Any Obstructions?	N/A			N/A
	Obstruction Type		Yes	Surface Condition? (G/P)	Good
			N/A	Curb Slope (%)	10.0

**Remove & Replace Entire Ramp.**

Total Cost: \$ 1600.00
