# Access Compliance Report

## Public Rights-of-Way

Intersection ID: 14311	Main Street: BERKELEY_AV	Cross Street: CARLTON_AV	Location: NE
ADA ID: 49299B8382AA	Ramp Type: Directional1	Initial Pass/Fail: Fail	Overall Compliance: No
		Severity Score: 1.25

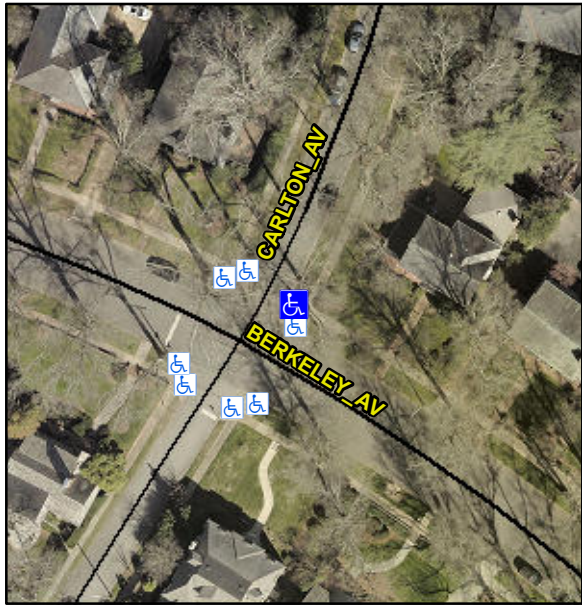
Possible Solutions:		<b>Compliance</b>	<b>Description</b>	<b>Data</b>	<b>Compliance</b>	<b>Description</b>	<b>Data</b>
	<b>Remove &amp; Replace Entire Ramp.</b>		N/A	Ramp Length (in)	54.0	N/A	Grade Break?	N/A
			Yes	Ramp Width (in)	60.0	N/A	Grade Break Slope (%)	0.0
			Yes	Ramp Slope (%)	5.6	N/A	Grade Break XSlope (%)	0.0
			No	Ramp XSlope (%)	3.1			
			N/A	Flare Type LT	N/A	N/A	Flare Type RT	N/A
			N/A	Flare Slope LT (%)	N/A	N/A	Flare Slope RT (%)	0.0
			N/A	Flare Traversable LT?	N/A	N/A	Flare Traversable RT?	N/A
			N/A	Landing Length (in)	0.0	N/A	DWS Provided?	N/A
			N/A	Landing Width (in)	0.0	N/A	DWS Contrast?	N/A
Surveyor Notes:			N/A	Landing Slope (%)	0.0	N/A	DWS Length (in)	N/A
<b>N/A</b>			N/A	Landing X Slope (%)	0.0	N/A	DWS Full Width?	N/A
PROW/ADA:			N/A	Landing Curb? (Y/N)	N/A	N/A	DWS Offset LT (in)	N/A

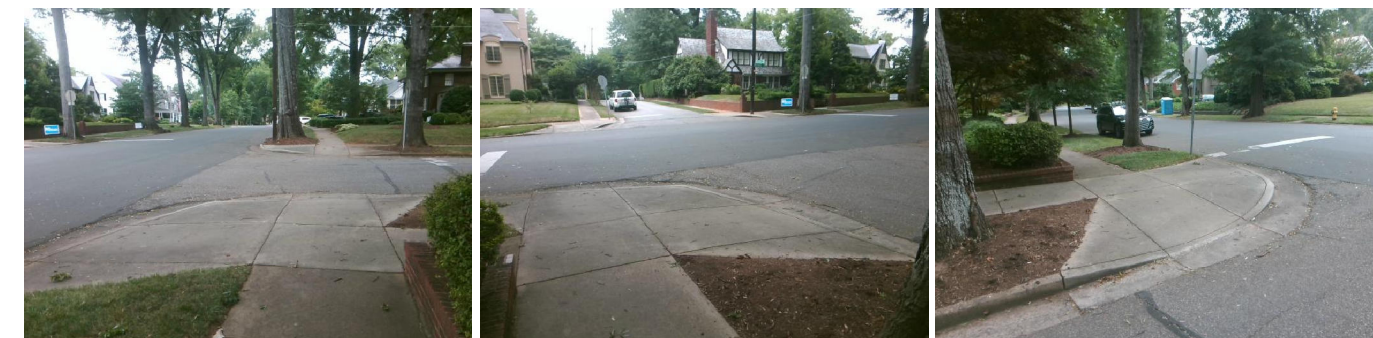
<b>R304.5.3</b>			N/A	Shared Landing?	N/A	N/A	DWS Offset RT (in)	N/A
			N/A	Gutter Ponding?	0.0	N/A	Gutter Slope (%)	N/A
			N/A	Gutter Lip Ht (in)	0.0	N/A	Gutter X Slope (%)	N/A
			N/A	Painted X Walk1?	No		Road Slope (%)	8.5
				X Walk 1 Direction	To W		Road X Slope (%)	0.5
				X Walk 1 Width (in)	N/A		Clear Space?	N/A
				X Walk 1 Slope (%)	8.5	N/A	Clear Space to XWalk (in)	N/A
				X Walk 1 X Slope (%)	0.5	N/A	Storm Grate/Utility Hazard?	N/A
			N/A	Ramp inside XWalk1?	N/A		Storm Grate/Utility Type	
			N/A	Any Obstructions?	N/A			N/A
				Obstruction Type		Yes	Surface Condition? (G/P)	Good
					N/A	N/A	Curb Slope (%)	11.9
Total Cost:		\$ 1600.00						
Street 1 Name			CARLTON AV					
Stop Condition-Street 1			StopSign					
Street 2 Name			N/A					
Stop Condition-Street 2			N/A
