# Access Compliance Report

## Public Rights-of-Way

### (Curb Ramps)

Intersection ID: 4677	Main Street: OLD_STATESVILLE_RD	Cross Street: HENDERSON_RD	Location: E
ADA ID: 492E78E1F73C	Ramp Type: Perp	Initial Pass/Fail: Fail	Overall Compliance: No
Severity Score: 33.75			
Codes/Mitigation Info/Possible Solution		Field Measurements/Component Compliance

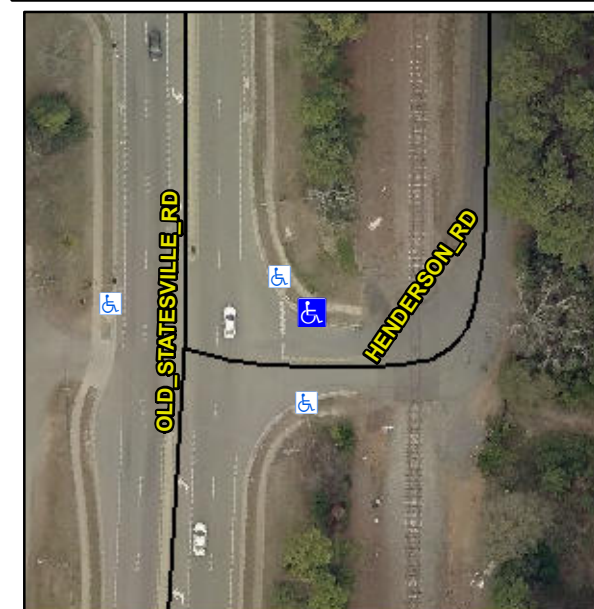
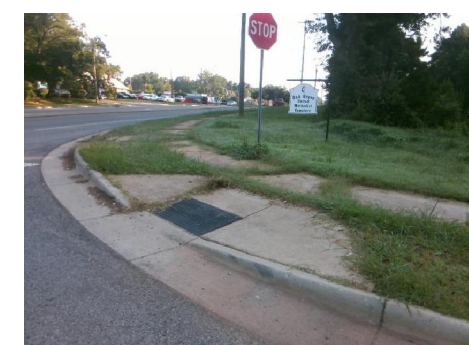
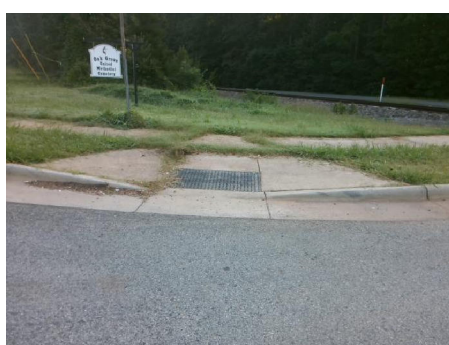
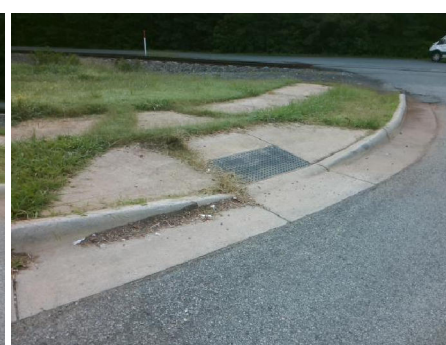
**Not Found, R304.5.1, R304.2.2**

Compliance	Description	Data	Compliance	Description	Data
N/A	Ramp Length (in)	59.0	No	Ramp Slope (%)	13.3
No	Ramp Width (in)	46.0	Yes	Ramp XSlope (%)	0.4
N/A	Flare Type LT	N/A	N/A	Flare Type RT	N/A
N/A	Flare Slope LT (%)	N/A	N/A	Flare Slope RT (%)	N/A
N/A	Flare Traversable LT?	N/A	N/A	Flare Traversable RT?	N/A
N/A	Landing Length (in)	N/A	N/A	DWS Provided?	N/A
N/A	Landing Width (in)	N/A	N/A	DWS Contrast?	N/A
N/A	Landing Slope (%)	N/A	N/A	DWS Length (in)	N/A
N/A	Landing X Slope (%)	N/A	N/A	DWS Full Width?	N/A
N/A	Landing Curb? (Y/N)	N/A	N/A	DWS Offset (in)	N/A
N/A	Shared Landing?	N/A			
N/A	Gutter Ponding?	N/A	N/A	Gutter Slope (%)	N/A
N/A	Gutter Lip Ht (in)	N/A	N/A	Gutter X Slope (%)	N/A
N/A	Painted X Walk1?	No	N/A	Painted X Walk2?	N/A
	X Walk 1 Direction	To S		X Walk 2 Direction	N/A
N/A	X Walk 1 Width (in)	N/A	N/A	X Walk 2 Width (in)	N/A
	X Walk 1 Slope (%)	2.1		X Walk 2 Slope (%)	N/A
	X Walk 1 X Slope (%)	0.0		X Walk 2 X Slope (%)	N/A

N/A	Ramp inside XWalk1?	N/A	N/A	Ramp inside XWalk2?	N/A
	Road Slope (%)	N/A	N/A	Clear Space?	N/A
	Road X Slope (%)	N/A	N/A	Clear Space to XWalk (in)	N/A
N/A	Any Obstructions?	N/A	N/A	Storm Grate/Utility Hazard?	N/A
	Obstruction Type			Storm Grate/Utility Type	
		N/A			N/A
			Yes	Surface Condition? (G/P)	Good

**Remove & Replace Entire Ramp.**
