Access Compliance Report

Public Rights-of-Way

(Curb Ramps)

Intersection ID: 29150	Main Street: DEATON_HILL_DR	Cross Street: HIGHLAND_PARK_DR	Location: NE
ADA ID: 494D0A631B18	Ramp Type: Perp	Initial Pass/Fail: Fail	Overall Compliance: No
Severity Score: 1.25			
Codes/Mitigation Info/Possible Solution		Field Measurements/Component Compliance

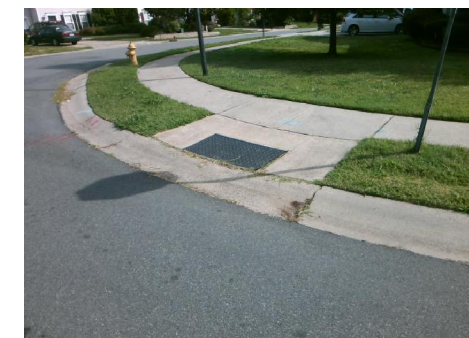
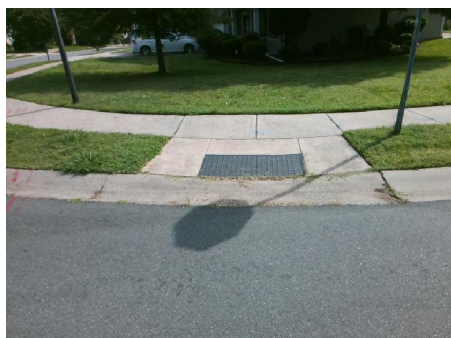
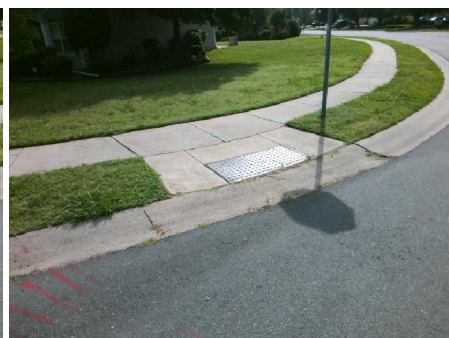
Compliance	Description	Data	Compliance	Description	Data
N/A	Ramp Length (in)	46.0	Yes	Ramp Slope (%)	5.3
Yes	Ramp Width (in)	48.0	No	Ramp XSlope (%)	2.6
N/A	Flare Type LT	N/A	N/A	Flare Type RT	N/A
N/A	Flare Slope LT (%)	N/A	N/A	Flare Slope RT (%)	N/A
N/A	Flare Traversable LT?	N/A	N/A	Flare Traversable RT?	N/A
N/A	Landing Length (in)	N/A	N/A	DWS Provided?	N/A
N/A	Landing Width (in)	N/A	N/A	DWS Contrast?	N/A
N/A	Landing Slope (%)	N/A	N/A	DWS Length (in)	N/A
N/A	Landing X Slope (%)	N/A	N/A	DWS Full Width?	N/A
N/A	Landing Curb? (Y/N)	N/A	N/A	DWS Offset (in)	N/A
N/A	Shared Landing?	N/A			
N/A	Gutter Ponding?	N/A	N/A	Gutter Slope (%)	N/A
N/A	Gutter Lip Ht (in)	N/A	N/A	Gutter X Slope (%)	N/A
N/A	Painted X Walk1?	No	N/A	Painted X Walk2?	N/A
	X Walk 1 Direction	To S		X Walk 2 Direction	N/A
N/A	X Walk 1 Width (in)	N/A	N/A	X Walk 2 Width (in)	N/A
	X Walk 1 Slope (%)	4.1		X Walk 2 Slope (%)	N/A
	X Walk 1 X Slope (%)	3.5		X Walk 2 X Slope (%)	N/A

N/A	Ramp inside XWalk1?	N/A	N/A	Ramp inside XWalk2?	N/A
	Road Slope (%)	N/A	N/A	Clear Space?	N/A
	Road X Slope (%)	N/A	N/A	Clear Space to XWalk (in)	N/A
N/A	Any Obstructions?	N/A	N/A	Storm Grate/Utility Hazard?	N/A
	Obstruction Type			Storm Grate/Utility Type	
		N/A			N/A
			Yes	Surface Condition? (G/P)	Good

Remove & Replace Entire Ramp.
