Access Compliance Report

Public Rights-of-Way

(Curb Ramps)

Intersection ID: 7018	Main Street: N_GRAHAM_ST	Cross Street: ONEIDA_RD	Location:	E
ADA ID: 4982B089EBCC	Ramp Type: Perp	Initial Pass/Fail: Fail	Overall Compliance: No	Severity Score: 12.5

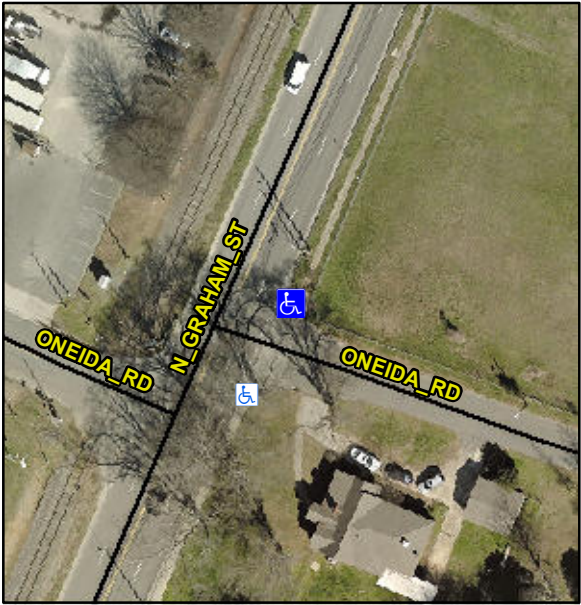
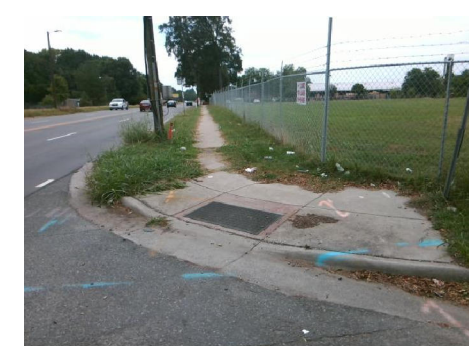
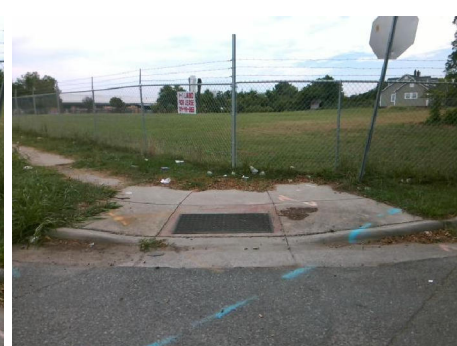
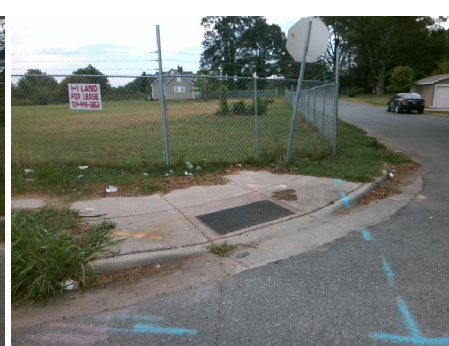
Possible Solutions:		Compliance	Description	Data
	Remove & Replace Entire Ramp.		No	Ramp Length (in)	41.0
			Yes	Ramp Width (in)	53.5
			N/A	Flare Type LT	N/A
			N/A	Flare Slope LT (%)	N/A
			N/A	Flare Traversable LT?	N/A
			N/A	Landing Length (in)	N/A
			N/A	Landing Width (in)	N/A
			N/A	Landing Slope (%)	N/A
			N/A	Landing X Slope (%)	N/A
<p>Surveyor Notes:</p> <p>N/A</p> <p>PROW/ADA:</p> <p>Not Found, R304.2.2</p>			N/A	Flare Type RT	N/A
			N/A	Flare Slope RT (%)	N/A
			N/A	Flare Traversable RT?	N/A
			N/A	DWS Provided?	N/A
			N/A	DWS Contrast?	N/A
			N/A	DWS Length (in)	N/A
			N/A	DWS Full Width?	N/A
			N/A	DWS Offset (in)	N/A
			N/A	Gutter Ponding?	N/A
			N/A	Gutter Lip Ht (in)	1.0
			No	Painted X Walk1?	N/A
				X Walk 1 Direction	To SW
			N/A	X Walk 1 Width (in)	N/A
				X Walk 1 Slope (%)	1.4
				X Walk 1 X Slope (%)	3.6

N/A	Ramp inside XWalk1?	N/A
			N/A	Road Slope (%)	N/A
			N/A	Road X Slope (%)	N/A
			N/A	Any Obstructions?	N/A
				Obstruction Type	
Total Cost:		\$ 1850.00	N/A	Clear Space?	N/A
			N/A	Clear Space to XWalk (in)	N/A
			N/A	Storm Grate/Utility Hazard?	N/A
				Storm Grate/Utility Type	
			Yes	Surface Condition? (G/P)	Good
