Access Compliance Report

Public Rights-of-Way

(Curb Ramps)

Intersection ID: 50342	Main Street: HERMISTON_ST	Cross Street: STIRLINGSHIRE_CT	Location: SE
ADA ID: 498A74559680	Ramp Type: Perp	Initial Pass/Fail: Fail	Overall Compliance: No
Severity Score: 22.5			
Codes/Mitigation Info/Possible Solution		Field Measurements/Component Compliance

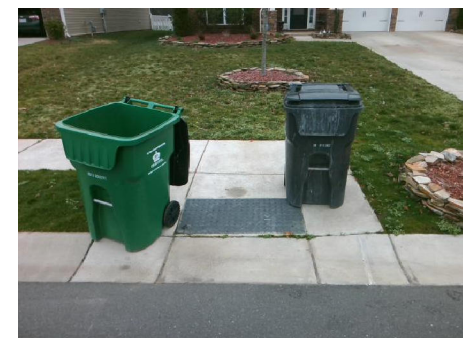
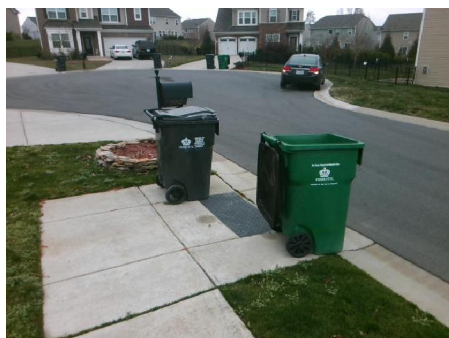
R304.5.1, R304.2.2, R304.5.3

Compliance	Description	Data	Compliance	Description	Data
N/A	Ramp Length (in)	48.0	No	Ramp Slope (%)	10.0
No	Ramp Width (in)	47.5	No	Ramp XSlope (%)	2.1
N/A	Flare Type LT	N/A	N/A	Flare Type RT	N/A
N/A	Flare Slope LT (%)	N/A	N/A	Flare Slope RT (%)	N/A
N/A	Flare Traversable LT?	N/A	N/A	Flare Traversable RT?	N/A
N/A	Landing Length (in)	N/A	N/A	DWS Provided?	N/A
N/A	Landing Width (in)	N/A	N/A	DWS Contrast?	N/A
N/A	Landing Slope (%)	N/A	N/A	DWS Length (in)	N/A
N/A	Landing X Slope (%)	N/A	N/A	DWS Full Width?	N/A
N/A	Landing Curb? (Y/N)	N/A	N/A	DWS Offset (in)	N/A
N/A	Shared Landing?	N/A			
N/A	Gutter Ponding?	N/A	N/A	Gutter Slope (%)	N/A
N/A	Gutter Lip Ht (in)	N/A	N/A	Gutter X Slope (%)	N/A
N/A	Painted X Walk1?	No	N/A	Painted X Walk2?	N/A
	X Walk 1 Direction	To W		X Walk 2 Direction	N/A
N/A	X Walk 1 Width (in)	N/A	N/A	X Walk 2 Width (in)	N/A
	X Walk 1 Slope (%)	2.5		X Walk 2 Slope (%)	N/A
	X Walk 1 X Slope (%)	1.0		X Walk 2 X Slope (%)	N/A

N/A	Ramp inside XWalk1?	N/A	N/A	Ramp inside XWalk2?	N/A
	Road Slope (%)	N/A	N/A	Clear Space?	N/A
	Road X Slope (%)	N/A	N/A	Clear Space to XWalk (in)	N/A
N/A	Any Obstructions?	N/A	N/A	Storm Grate/Utility Hazard?	N/A
	Obstruction Type			Storm Grate/Utility Type	
		N/A			N/A
			Yes	Surface Condition? (G/P)	Good

Possible Solutions:

Remove & Replace Entire Ramp.
