# Access Compliance Report

## Public Rights-of-Way

### (Curb Ramps)

Intersection ID: 15555	Main Street: EASTOVER RIDGE DR	Cross Street: RANDOLPH RD	Location: N
ADA ID: 499B40AFAC73	Ramp Type: PerpDiag	Initial Pass/Fail: Fail	Overall Compliance: No
Codes/Mitigation Info/Possible Solution		Field Measurements/Component Compliance

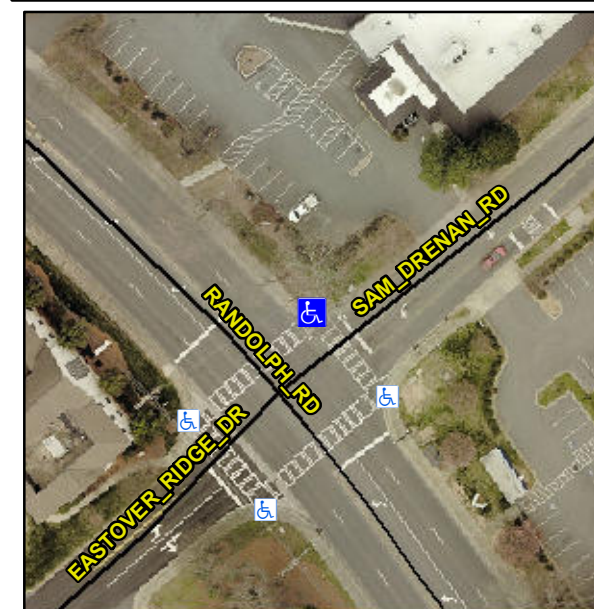
Compliance	Description	Data	Compliance	Description	Data
N/A	Ramp Length (in)	51.0	No	Ramp Slope (%)	9.9
Yes	Ramp Width (in)	48.0	No	Ramp XSlope (%)	3.4
N/A	Flare Type LT	N/A	N/A	Flare Type RT	N/A
N/A	Flare Slope LT (%)	N/A	N/A	Flare Slope RT (%)	N/A
N/A	Flare Traversable LT?	N/A	N/A	Flare Traversable RT?	N/A
N/A	Landing Length (in)	N/A	N/A	DWS Provided?	N/A
N/A	Landing Width (in)	N/A	N/A	DWS Contrast?	N/A
N/A	Landing Slope (%)	N/A	N/A	DWS Length (in)	N/A
N/A	Landing X Slope (%)	N/A	N/A	DWS Full Width?	N/A
N/A	Landing Curb? (Y/N)	N/A	N/A	DWS Offset (in)	N/A
N/A	Shared Landing?	N/A			
N/A	Gutter Ponding?	N/A	N/A	Gutter Slope (%)	N/A
N/A	Gutter Lip Ht (in)	N/A	N/A	Gutter X Slope (%)	N/A
N/A	Painted X Walk1?	Yes	N/A	Painted X Walk2?	Yes
	X Walk 1 Direction	To SW		X Walk 2 Direction	To SE
N/A	X Walk 1 Width (in)	102.0	N/A	X Walk 2 Width (in)	105.0
	X Walk 1 Slope (%)	1.3		X Walk 2 Slope (%)	1.0
	X Walk 1 X Slope (%)	2.4		X Walk 2 X Slope (%)	3.9

N/A	Ramp inside XWalk1?	Yes	N/A	Ramp inside XWalk2?	Yes
	Road Slope (%)	1.8	N/A	Clear Space?	N/A
	Road X Slope (%)	0.8	N/A	Clear Space to XWalk (in)	N/A
N/A	Any Obstructions?	N/A	N/A	Storm Grate/Utility Hazard?	N/A
	Obstruction Type			Storm Grate/Utility Type	
		N/A			N/A
			Yes	Surface Condition? (G/P)	Good

**Remove & Replace Curb Ramp With Two New Directional Ramps or Equivalent.**

**R304.2.2, R304.5.3**
