## Access Compliance Report Public Rights-of-Way (Curb Ramps)

Intersection ID: 13007 Main Street: HAWTHORNE\_LN Cross Street: CENTRAL\_AV Location: SW

ADA ID: 49A3F3F33515 Ramp Type: PerpDiag Initial Pass/Fail: Fail Overall Compliance: No Severity Score: 22.5

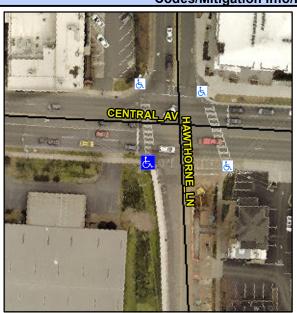
Not Found, R304.5.1, R304.2.2, R304.5.3

Compliance Description Data Compliance Description No N/A Ramp Length (in) 63.0 Ramp Slope (%) No Ramp XSlope (%) No Ramp Width (in) 46.0 N/A N/A Flare Type LT N/A Flare Type RT N/A Flare Slope LT (%) N/A N/A Flare Slope RT (%) N/A Flare Traversable LT? N/A N/A Flare Traversable RT? N/A Landing Length (in) N/A N/A **DWS Provided?** N/A Landing Width (in) N/A N/A **DWS Contrast?** N/A N/A N/A Landing Slope (%) DWS Length (in) N/A Landing X Slope (%) N/A N/A DWS Full Width? N/A Landing Curb? (Y/N) N/A N/A DWS Offset (in) N/A N/A Shared Landing? N/A **Gutter Ponding?** N/A N/A Gutter Slope (%) N/A Gutter Lip Ht (in) N/A N/A Gutter X Slope (%) N/A Painted X Walk1? Yes N/A Painted X Walk2? X Walk 1 Direction To E X Walk 2 Direction N/A 105.0 X Walk 2 Width (in) X Walk 1 Width (in) X Walk 1 Slope (%) 0.2 X Walk 2 Slope (%) 2.7 X Walk 2 X Slope (%) X Walk 1 X Slope (%) N/A N/A Ramp inside XWalk2? Ramp inside XWalk1? Yes Road Slope (%) 3.2 N/A Clear Space? N/A Road X Slope (%) 1.3 Clear Space to XWalk (in) N/A N/A N/A Any Obstructions? Storm Grate/Utility Hazard?

Remove & Replace Curb Ramp With Two New Directional Ramps or Equivalent.
