Access Compliance Report

Public Rights-of-Way

(Curb Ramps)

Intersection ID: 49275	Main Street: GATHERING_CT	Cross Street: REUNION_ST	Location: SE
ADA ID: 49AF60395FC3	Ramp Type: PerpDiag	Initial Pass/Fail: Fail	Overall Compliance: No
Severity Score: 8.75			
Codes/Mitigation Info/Possible Solution		Field Measurements/Component Compliance

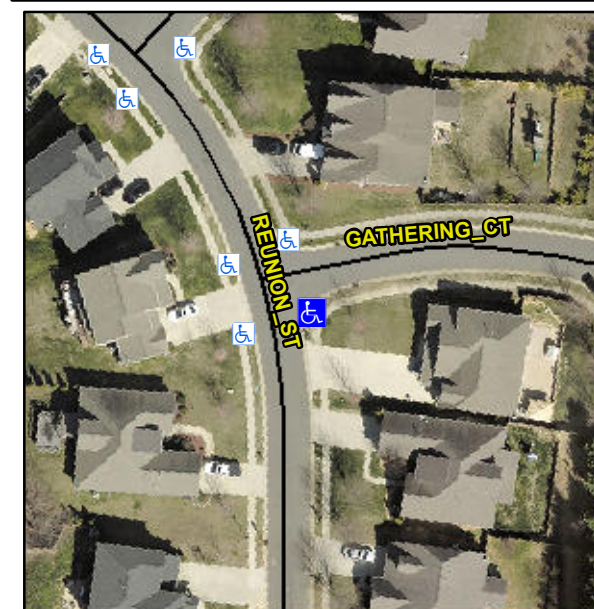
Not Found, R304.5.1

Compliance	Description	Data	Compliance	Description	Data
N/A	Ramp Length (in)	48.5	Yes	Ramp Slope (%)	5.5
No	Ramp Width (in)	46.0	Yes	Ramp XSlope (%)	1.2
N/A	Flare Type LT	N/A	N/A	Flare Type RT	N/A
N/A	Flare Slope LT (%)	N/A	N/A	Flare Slope RT (%)	N/A
N/A	Flare Traversable LT?	N/A	N/A	Flare Traversable RT?	N/A
N/A	Landing Length (in)	N/A	N/A	DWS Provided?	N/A
N/A	Landing Width (in)	N/A	N/A	DWS Contrast?	N/A
N/A	Landing Slope (%)	N/A	N/A	DWS Length (in)	N/A
N/A	Landing X Slope (%)	N/A	N/A	DWS Full Width?	N/A
N/A	Landing Curb? (Y/N)	N/A	N/A	DWS Offset (in)	N/A
N/A	Shared Landing?	N/A			
N/A	Gutter Ponding?	N/A	N/A	Gutter Slope (%)	N/A
N/A	Gutter Lip Ht (in)	N/A	N/A	Gutter X Slope (%)	N/A
N/A	Painted X Walk1?	No	N/A	Painted X Walk2?	No
	X Walk 1 Direction	To N		X Walk 2 Direction	To W
N/A	X Walk 1 Width (in)	N/A	N/A	X Walk 2 Width (in)	N/A
	X Walk 1 Slope (%)	2.5		X Walk 2 Slope (%)	2.1
	X Walk 1 X Slope (%)	1.2		X Walk 2 X Slope (%)	0.1

N/A	Ramp inside XWalk1?	N/A	N/A	Ramp inside XWalk2?	N/A
	Road Slope (%)	2.4	N/A	Clear Space?	N/A
	Road X Slope (%)	0.5	N/A	Clear Space to XWalk (in)	N/A
N/A	Any Obstructions?	N/A	N/A	Storm Grate/Utility Hazard?	N/A
	Obstruction Type			Storm Grate/Utility Type	
		N/A			N/A
		Yes		Surface Condition? (G/P)	Good

Remove & Replace Curb Ramp With Two New Directional Ramps or Equivalent.
