# Access Compliance Report

## Public Rights-of-Way

### (Curb Ramps)

Intersection ID: 14401	Main Street: BAXTER_ST	Cross Street: BALDWIN_AV	Location: E
ADA ID: 49B1A9C0B965	Ramp Type: PerpDiag	Initial Pass/Fail: Fail	Overall Compliance: No
			Severity Score: 13.75

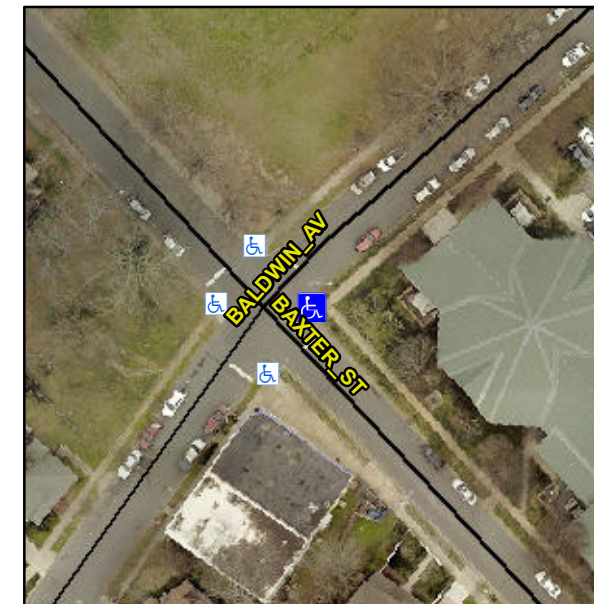
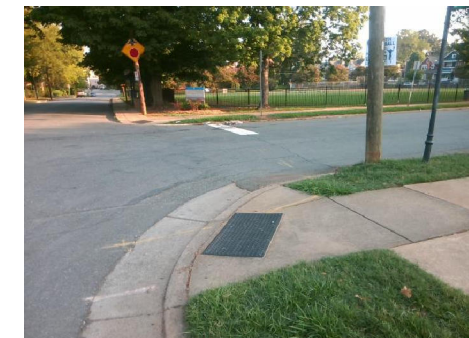
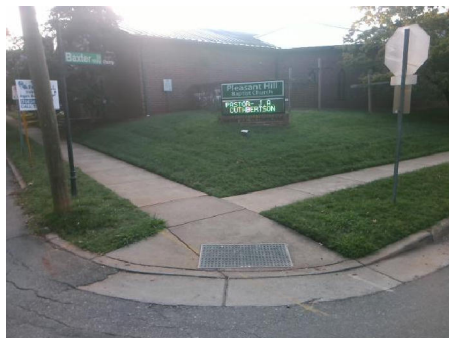
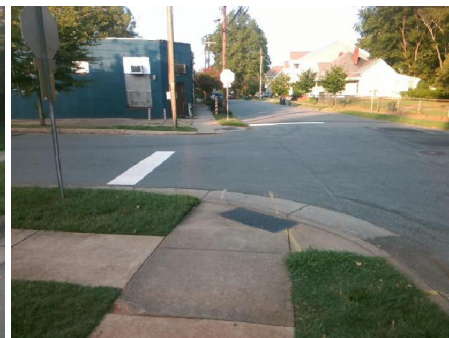
Compliance	Description	Data	Compliance	Description	Data
N/A	Ramp Length (in)	36.0	No	Ramp Slope (%)	8.4
Yes	Ramp Width (in)	48.0	No	Ramp XSlope (%)	3.2
N/A	Flare Type LT	N/A	N/A	Flare Type RT	N/A
N/A	Flare Slope LT (%)	N/A	N/A	Flare Slope RT (%)	N/A
N/A	Flare Traversable LT?	N/A	N/A	Flare Traversable RT?	N/A
N/A	Landing Length (in)	N/A	N/A	DWS Provided?	N/A
N/A	Landing Width (in)	N/A	N/A	DWS Contrast?	N/A
N/A	Landing Slope (%)	N/A	N/A	DWS Length (in)	N/A
N/A	Landing X Slope (%)	N/A	N/A	DWS Full Width?	N/A
N/A	Landing Curb? (Y/N)	N/A	N/A	DWS Offset (in)	N/A
N/A	Shared Landing?	N/A			
N/A	Gutter Ponding?	N/A	N/A	Gutter Slope (%)	N/A
N/A	Gutter Lip Ht (in)	N/A	N/A	Gutter X Slope (%)	N/A
N/A	Painted X Walk1?	No	N/A	Painted X Walk2?	No
	X Walk 1 Direction	To NW		X Walk 2 Direction	To SW
N/A	X Walk 1 Width (in)	N/A	N/A	X Walk 2 Width (in)	N/A
	X Walk 1 Slope (%)	3.0		X Walk 2 Slope (%)	0.6
	X Walk 1 X Slope (%)	0.2		X Walk 2 X Slope (%)	2.9

N/A	Ramp inside XWalk1?	N/A	N/A	Ramp inside XWalk2?	N/A
	Road Slope (%)	2.5	N/A	Clear Space?	N/A
	Road X Slope (%)	5.0	N/A	Clear Space to XWalk (in)	N/A
N/A	Any Obstructions?	N/A	N/A	Storm Grate/Utility Hazard?	N/A
	Obstruction Type			Storm Grate/Utility Type	
		N/A			N/A
			Yes	Surface Condition? (G/P)	Good

**Remove & Replace Curb Ramp With Two New Directional Ramps or Equivalent.**

**R304.2.2, R304.5.3**
