# Access Compliance Report

## Public Rights-of-Way

### (Curb Ramps)

Intersection ID: 8515	Main Street: ATANDO_AV	Cross Street: STATESVILLE_AV	Location: NE
ADA ID: 49C77112732D	Ramp Type: Perp	Initial Pass/Fail: Fail	Overall Compliance: No
Severity Score: 21.25			
Codes/Mitigation Info/Possible Solution		Field Measurements/Component Compliance

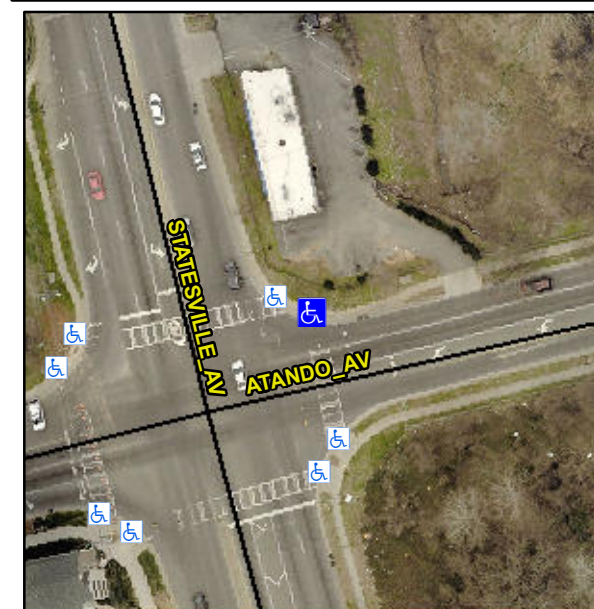
Compliance	Description	Data	Compliance	Description	Data
N/A	Ramp Length (in)	60.0	No	Ramp Slope (%)	9.4
No	Ramp Width (in)	45.0	Yes	Ramp XSlope (%)	0.2
N/A	Flare Type LT	N/A	N/A	Flare Type RT	N/A
N/A	Flare Slope LT (%)	N/A	N/A	Flare Slope RT (%)	N/A
N/A	Flare Traversable LT?	N/A	N/A	Flare Traversable RT?	N/A
N/A	Landing Length (in)	N/A	N/A	DWS Provided?	N/A
N/A	Landing Width (in)	N/A	N/A	DWS Contrast?	N/A
N/A	Landing Slope (%)	N/A	N/A	DWS Length (in)	N/A
N/A	Landing X Slope (%)	N/A	N/A	DWS Full Width?	N/A
N/A	Landing Curb? (Y/N)	N/A	N/A	DWS Offset (in)	N/A
N/A	Shared Landing?	N/A			
N/A	Gutter Ponding?	N/A	N/A	Gutter Slope (%)	N/A
N/A	Gutter Lip Ht (in)	N/A	N/A	Gutter X Slope (%)	N/A
N/A	Painted X Walk1?	No	N/A	Painted X Walk2?	N/A
	X Walk 1 Direction	To S		X Walk 2 Direction	N/A
N/A	X Walk 1 Width (in)	N/A	N/A	X Walk 2 Width (in)	N/A
	X Walk 1 Slope (%)	1.7		X Walk 2 Slope (%)	N/A
	X Walk 1 X Slope (%)	0.3		X Walk 2 X Slope (%)	N/A

N/A	Ramp inside XWalk1?	N/A	N/A	Ramp inside XWalk2?	N/A
	Road Slope (%)	N/A	N/A	Clear Space?	N/A
	Road X Slope (%)	N/A	N/A	Clear Space to XWalk (in)	N/A
N/A	Any Obstructions?	N/A	N/A	Storm Grate/Utility Hazard?	N/A
	Obstruction Type			Storm Grate/Utility Type	
		N/A			N/A
			Yes	Surface Condition? (G/P)	Good

Possible Solutions:

**Remove & Replace Entire Ramp.**

**R304.5.1, R304.2.2**

Total Cost: \$ 1850.00
