Access Compliance Report

Public Rights-of-Way

(Curb Ramps)

Intersection ID: 31896	Main Street: GREEN_MOUNTAIN_RD	Cross Street: SHOPTON_RD_WEST	Location: SW
ADA ID: 49CD7C82C8D2	Ramp Type: PerpDiag	Initial Pass/Fail: Fail	Overall Compliance: No
Severity Score: 22.5			
Codes/Mitigation Info/Possible Solution		Field Measurements/Component Compliance

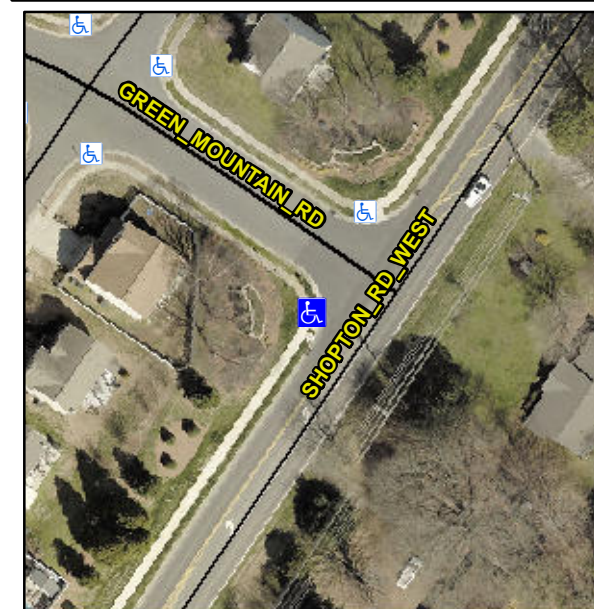
Not Found, R304.5.1, R304.2.2, R304.5.3

Compliance	Description	Data	Compliance	Description	Data
N/A	Ramp Length (in)	47.5	No	Ramp Slope (%)	8.6
No	Ramp Width (in)	47.0	No	Ramp XSlope (%)	3.9
N/A	Flare Type LT	N/A	N/A	Flare Type RT	N/A
N/A	Flare Slope LT (%)	N/A	N/A	Flare Slope RT (%)	N/A
N/A	Flare Traversable LT?	N/A	N/A	Flare Traversable RT?	N/A
N/A	Landing Length (in)	N/A	N/A	DWS Provided?	N/A
N/A	Landing Width (in)	N/A	N/A	DWS Contrast?	N/A
N/A	Landing Slope (%)	N/A	N/A	DWS Length (in)	N/A
N/A	Landing X Slope (%)	N/A	N/A	DWS Full Width?	N/A
N/A	Landing Curb? (Y/N)	N/A	N/A	DWS Offset (in)	N/A
N/A	Shared Landing?	N/A			
N/A	Gutter Ponding?	N/A	N/A	Gutter Slope (%)	N/A
N/A	Gutter Lip Ht (in)	N/A	N/A	Gutter X Slope (%)	N/A
N/A	Painted X Walk1?	No	N/A	Painted X Walk2?	No
	X Walk 1 Direction	To SE		X Walk 2 Direction	To NE
N/A	X Walk 1 Width (in)	N/A	N/A	X Walk 2 Width (in)	N/A
	X Walk 1 Slope (%)	0.3		X Walk 2 Slope (%)	0.8
	X Walk 1 X Slope (%)	3.7		X Walk 2 X Slope (%)	1.3

N/A	Ramp inside XWalk1?	N/A	N/A	Ramp inside XWalk2?	N/A
	Road Slope (%)	0.5	N/A	Clear Space?	N/A
	Road X Slope (%)	1.6	N/A	Clear Space to XWalk (in)	N/A
N/A	Any Obstructions?	N/A	N/A	Storm Grate/Utility Hazard?	N/A
	Obstruction Type			Storm Grate/Utility Type	
		N/A			N/A
			Yes	Surface Condition? (G/P)	Good

Remove & Replace Curb Ramp With Two New Directional Ramps or Equivalent.
