Access Compliance Report

Public Rights-of-Way

(Curb Ramps)

Intersection ID: 16114	Main Street: HAMPTON_AV	Cross Street: OXFORD_PL	Location: SW
ADA ID: 49DAD46403AB	Ramp Type: PerpDiag	Initial Pass/Fail: Fail	Overall Compliance: No
Severity Score: 37.5			
Codes/Mitigation Info/Possible Solution		Field Measurements/Component Compliance

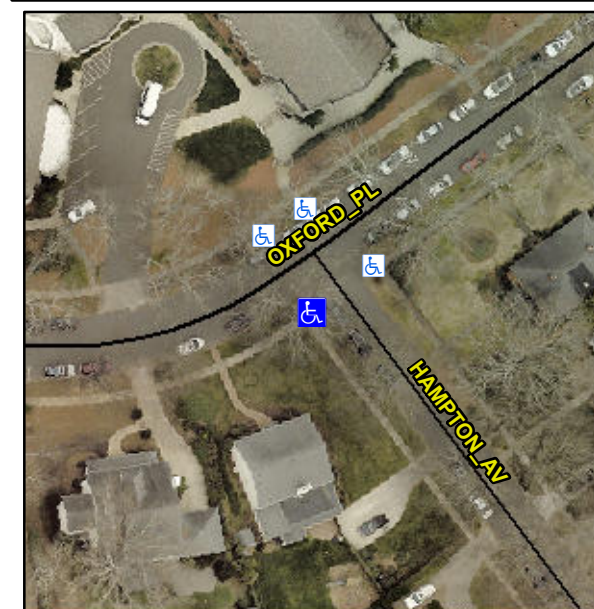
Compliance	Description	Data	Compliance	Description	Data
N/A	Ramp Length (in)	82.0	No	Ramp Slope (%)	17.1
Yes	Ramp Width (in)	48.0	No	Ramp XSlope (%)	6.0
N/A	Flare Type LT	N/A	N/A	Flare Type RT	N/A
N/A	Flare Slope LT (%)	N/A	N/A	Flare Slope RT (%)	N/A
N/A	Flare Traversable LT?	N/A	N/A	Flare Traversable RT?	N/A
N/A	Landing Length (in)	N/A	N/A	DWS Provided?	N/A
N/A	Landing Width (in)	N/A	N/A	DWS Contrast?	N/A
N/A	Landing Slope (%)	N/A	N/A	DWS Length (in)	N/A
N/A	Landing X Slope (%)	N/A	N/A	DWS Full Width?	N/A
N/A	Landing Curb? (Y/N)	N/A	N/A	DWS Offset (in)	N/A
N/A	Shared Landing?	N/A			
N/A	Gutter Ponding?	N/A	N/A	Gutter Slope (%)	N/A
N/A	Gutter Lip Ht (in)	2.0	N/A	Gutter X Slope (%)	N/A
N/A	Painted X Walk1?	No	N/A	Painted X Walk2?	No
	X Walk 1 Direction	To NE		X Walk 2 Direction	To N
N/A	X Walk 1 Width (in)	N/A	N/A	X Walk 2 Width (in)	N/A
	X Walk 1 Slope (%)	0.2		X Walk 2 Slope (%)	3.4
	X Walk 1 X Slope (%)	2.5		X Walk 2 X Slope (%)	1.4

N/A	Ramp inside XWalk1?	N/A	N/A	Ramp inside XWalk2?	N/A
	Road Slope (%)	1.5	N/A	Clear Space?	N/A
	Road X Slope (%)	4.4	N/A	Clear Space to XWalk (in)	N/A
N/A	Any Obstructions?	N/A	N/A	Storm Grate/Utility Hazard?	N/A
	Obstruction Type			Storm Grate/Utility Type	
		N/A			N/A
			Yes	Surface Condition? (G/P)	Good

Possible Solutions:

Remove & Replace Curb Ramp With Two New Directional Ramps or Equivalent.
