| Intersection ID: 44214 | Main Street: NATIONS_FORD_RD | Cross Street: TYVOLA_GLEN_CR | Location: | S |
| ADA ID: 49E44076D87E | Ramp Type: PerpDiag | Initial Pass/Fail: Fail | Overall Compliance: No | Severity Score: 21.25 |

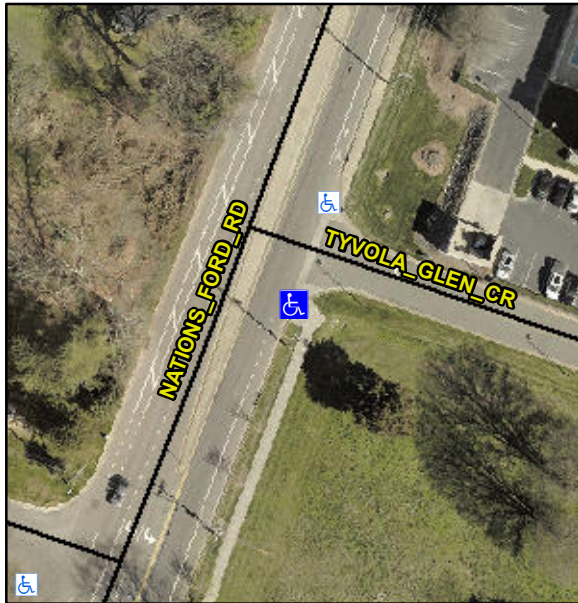
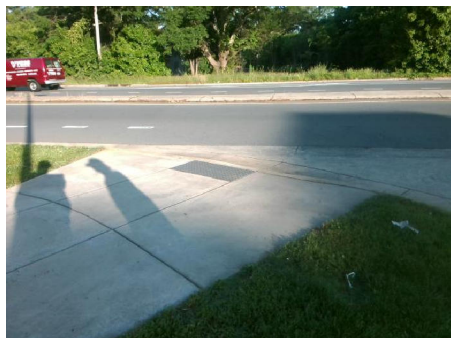
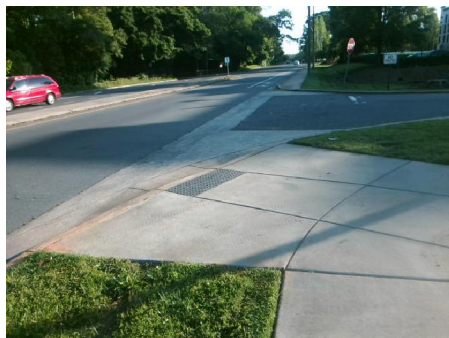
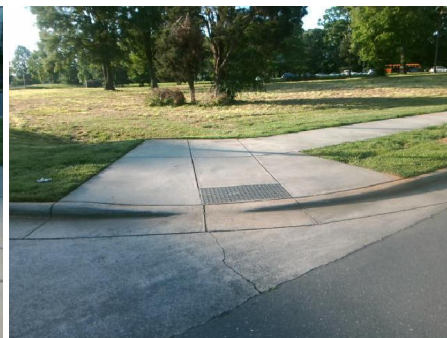
**Not Found, R304.5.1, R304.5.3**

| Compliance | Description | Data | Compliance | Description | Data |
|---|---|---|---|---|---|
| N/A | Ramp Length (in) | 93.0 | Yes | Ramp Slope (%) | 5.3 |
| No | Ramp Width (in) | 37.0 | No | Ramp XSlope (%) | 6.1 |

**Remove & Replace Curb Ramp With Two New Directional Ramps or Equivalent.**
