Access Compliance Report

Public Rights-of-Way

(Curb Ramps)

Intersection ID: 44486	Main Street: NEWFIELD_ST	Cross Street: DARWICK_ST	Location: NW
ADA ID: 49EB5D0FBDF5	Ramp Type: Perp	Initial Pass/Fail: Fail	Overall Compliance: No
		Severity Score: 8.75

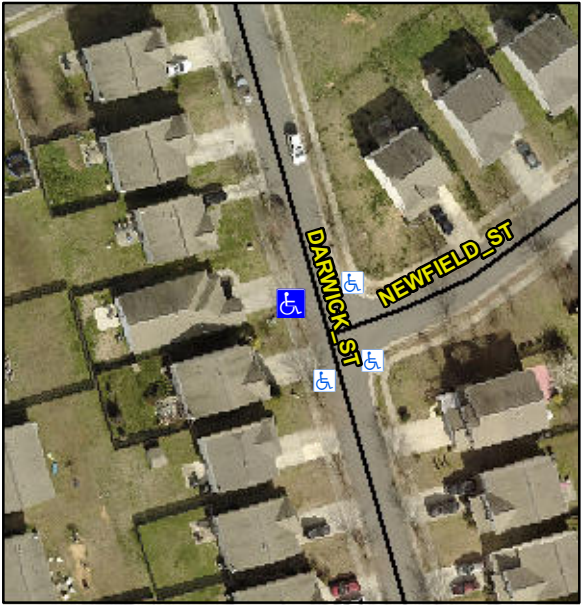
Possible Solutions:		Compliance	Description	Data
	Remove & Replace Entire Ramp.		N/A	Ramp Length (in)	48.5
			No	Ramp Width (in)	44.0
			N/A	Flare Type LT	N/A
			N/A	Flare Slope LT (%)	N/A
			N/A	Flare Traversable LT?	N/A
			N/A	Landing Length (in)	N/A
			N/A	Landing Width (in)	N/A
			N/A	Landing Slope (%)	N/A
			N/A	Landing X Slope (%)	N/A
<p>Surveyor Notes:</p> <p>N/A</p> <p>PROW/ADA:</p> <p>Not Found, R304.5.1</p>			N/A	Flare Type RT	N/A
			N/A	Flare Slope RT (%)	N/A
			N/A	Flare Traversable RT?	N/A
			N/A	DWS Provided?	N/A
			N/A	DWS Contrast?	N/A
			N/A	DWS Length (in)	N/A
			N/A	DWS Full Width?	N/A
			N/A	DWS Offset (in)	N/A
			N/A	Gutter Ponding?	N/A
			N/A	Gutter Lip Ht (in)	N/A
			No	Painted X Walk1?	N/A
				X Walk 1 Direction	To E
			N/A	X Walk 1 Width (in)	N/A
				X Walk 1 Slope (%)	4.2
				X Walk 1 X Slope (%)	1.9
			N/A	Ramp inside XWalk1?	N/A

N/A	Road Slope (%)	N/A
			N/A	Road X Slope (%)	N/A
			N/A	Any Obstructions?	N/A
				Obstruction Type	
Total Cost:			\$	1850.00	
			N/A		N/A
			Yes	Surface Condition? (G/P)	Good
