# Access Compliance Report

## Public Rights-of-Way

### (Curb Ramps)

Intersection ID: 2755	Main Street: BELL'S_MILL_DR	Cross Street: RIDGEFIELD_DR	Location: S
ADA ID: 49F598458863	Ramp Type: Perp	Initial Pass/Fail: Fail	Overall Compliance: No
Severity Score: 22.5			
Codes/Mitigation Info/Possible Solution		Field Measurements/Component Compliance

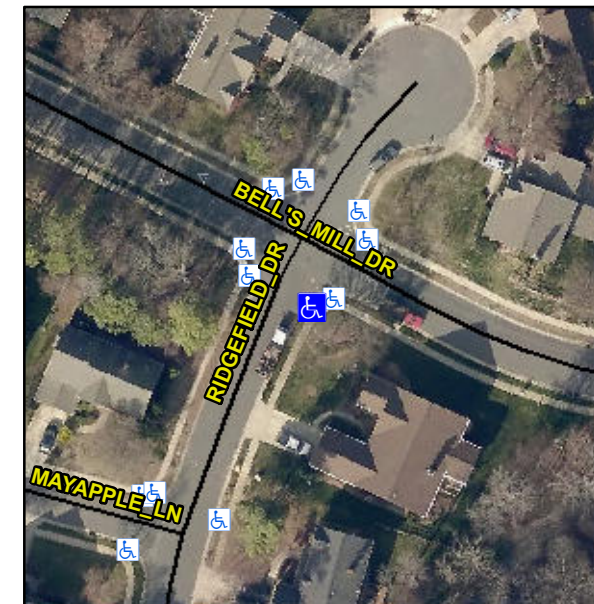
**R304.5.1, R304.2.2, R304.5.3**

Compliance	Description	Data	Compliance	Description	Data
N/A	Ramp Length (in)	50.0	No	Ramp Slope (%)	8.8
No	Ramp Width (in)	38.0	No	Ramp XSlope (%)	3.5
N/A	Flare Type LT	N/A	N/A	Flare Type RT	N/A
N/A	Flare Slope LT (%)	N/A	N/A	Flare Slope RT (%)	N/A
N/A	Flare Traversable LT?	N/A	N/A	Flare Traversable RT?	N/A
N/A	Landing Length (in)	N/A	N/A	DWS Provided?	N/A
N/A	Landing Width (in)	N/A	N/A	DWS Contrast?	N/A
N/A	Landing Slope (%)	N/A	N/A	DWS Length (in)	N/A
N/A	Landing X Slope (%)	N/A	N/A	DWS Full Width?	N/A
N/A	Landing Curb? (Y/N)	N/A	N/A	DWS Offset (in)	N/A
N/A	Shared Landing?	N/A			
N/A	Gutter Ponding?	N/A	N/A	Gutter Slope (%)	N/A
N/A	Gutter Lip Ht (in)	N/A	N/A	Gutter X Slope (%)	N/A
N/A	Painted X Walk1?	No	N/A	Painted X Walk2?	N/A
	X Walk 1 Direction	To NW		X Walk 2 Direction	N/A
N/A	X Walk 1 Width (in)	N/A	N/A	X Walk 2 Width (in)	N/A
	X Walk 1 Slope (%)	4.5		X Walk 2 Slope (%)	N/A
	X Walk 1 X Slope (%)	0.9		X Walk 2 X Slope (%)	N/A

N/A	Ramp inside XWalk1?	N/A	N/A	Ramp inside XWalk2?	N/A
	Road Slope (%)	N/A	N/A	Clear Space?	N/A
	Road X Slope (%)	N/A	N/A	Clear Space to XWalk (in)	N/A
N/A	Any Obstructions?	N/A	N/A	Storm Grate/Utility Hazard?	N/A
	Obstruction Type			Storm Grate/Utility Type	
		N/A			N/A
			Yes	Surface Condition? (G/P)	Good

**Remove & Replace Entire Ramp.**

Total Cost: \$ 1850.00
