# Access Compliance Report

## Public Rights-of-Way

### (Curb Ramps)

Intersection ID: 12681	Main Street: PALOVERDE_LN	Cross Street: PENCE_RD	Location: SW
ADA ID: 49FA0640C28D	Ramp Type: PerpDiag	Initial Pass/Fail: Fail	Overall Compliance: No
			Severity Score: 13.75

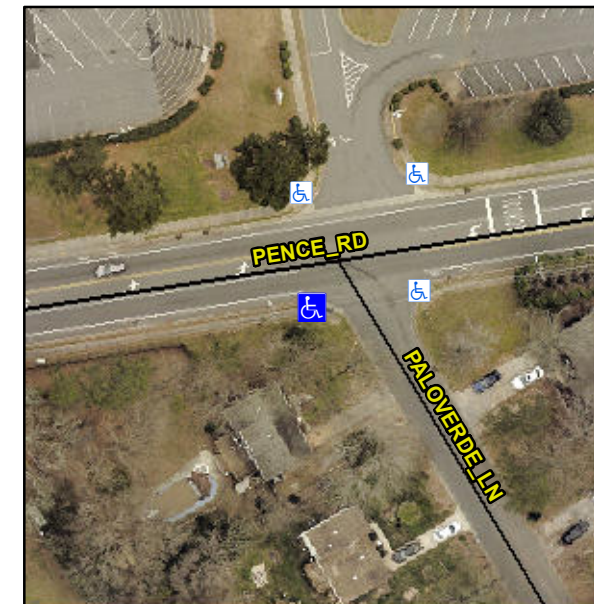
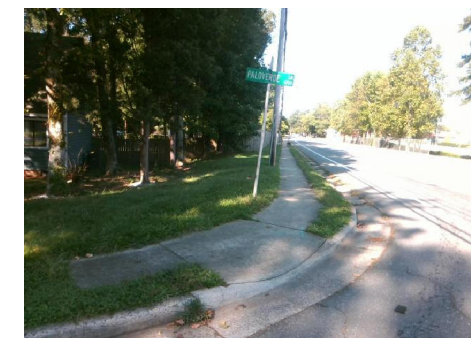
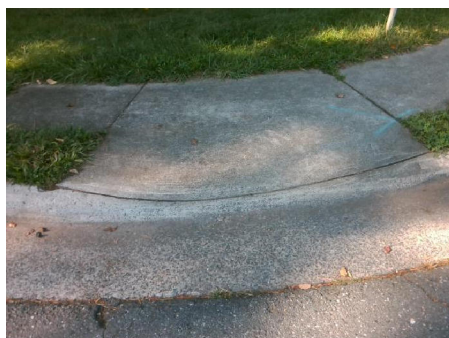
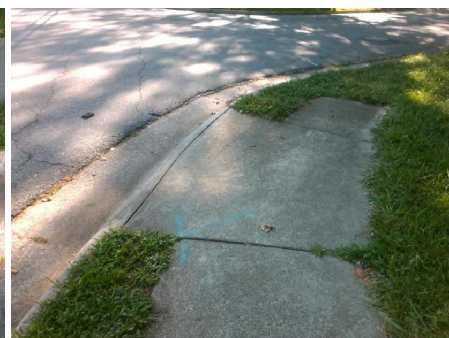
**Not Found, R304.2.2, R304.5.3**

Compliance	Description	Data	Compliance	Description	Data
N/A	Ramp Length (in)	73.5	No	Ramp Slope (%)	9.3
Yes	Ramp Width (in)	50.0	No	Ramp XSlope (%)	4.7
N/A	Flare Type LT	N/A	N/A	Flare Type RT	N/A
N/A	Flare Slope LT (%)	N/A	N/A	Flare Slope RT (%)	N/A
N/A	Flare Traversable LT?	N/A	N/A	Flare Traversable RT?	N/A
N/A	Landing Length (in)	N/A	N/A	DWS Provided?	N/A
N/A	Landing Width (in)	N/A	N/A	DWS Contrast?	N/A
N/A	Landing Slope (%)	N/A	N/A	DWS Length (in)	N/A
N/A	Landing X Slope (%)	N/A	N/A	DWS Full Width?	N/A
N/A	Landing Curb? (Y/N)	N/A	N/A	DWS Offset (in)	N/A
N/A	Shared Landing?	N/A			
N/A	Gutter Ponding?	N/A	N/A	Gutter Slope (%)	N/A
N/A	Gutter Lip Ht (in)	2.0	N/A	Gutter X Slope (%)	N/A
N/A	Painted X Walk1?	No	N/A	Painted X Walk2?	No
	X Walk 1 Direction	To E		X Walk 2 Direction	To N
N/A	X Walk 1 Width (in)	N/A	N/A	X Walk 2 Width (in)	N/A
	X Walk 1 Slope (%)	1.5		X Walk 2 Slope (%)	7.0
	X Walk 1 X Slope (%)	3.1		X Walk 2 X Slope (%)	0.3

N/A	Ramp inside XWalk1?	N/A	N/A	Ramp inside XWalk2?	N/A
	Road Slope (%)	3.3	N/A	Clear Space?	N/A
	Road X Slope (%)	6.8	N/A	Clear Space to XWalk (in)	N/A
N/A	Any Obstructions?	N/A	N/A	Storm Grate/Utility Hazard?	N/A
	Obstruction Type			Storm Grate/Utility Type	
		N/A			N/A
			Yes	Surface Condition? (G/P)	Good

**Remove & Replace Curb Ramp With Two New Directional Ramps or Equivalent.**
