Access Compliance Report Public Rights-of-Way (Curb Ramps)

Intersection ID: N/A Main Street: MARKLAND_DR Cross Street: PARKMONT_DR Location: SE

ADA ID: 4A01A817842E Ramp Type: PerpDiag Initial Pass/Fail: Fail Overall Compliance: No Severity Score: 21.25

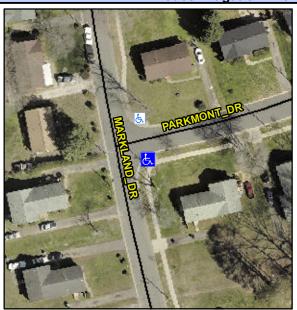
Compliance Description		Data	Compliance Description		Data
N/A	A Ramp Length (in)	73.0	No	Ramp Slope (%)	9.9
No	Ramp Width (in)	47.0	Yes	Ramp XSlope (%)	1.4
N/A	A Flare Type LT	N/A	N/A	Flare Type RT	N/A
N/A	A Flare Slope LT (%)	N/A	N/A	Flare Slope RT (%)	N/A
N/A	A Flare Traversable LT?	N/A	N/A	Flare Traversable RT?	N/A
N/A	A Landing Length (in)	N/A	N/A	DWS Provided?	N/A
N/A	A Landing Width (in)	N/A	N/A	DWS Contrast?	N/A
N/A	A Landing Slope (%)	N/A	N/A	DWS Length (in)	N/A
N/A	A Landing X Slope (%)	N/A	N/A	DWS Full Width?	N/A
N/A	A Landing Curb? (Y/N)	N/A	N/A	DWS Offset (in)	N/A
N/A	A Shared Landing?	N/A			
N/A	A Gutter Ponding?	N/A	N/A	Gutter Slope (%)	N/A
N/A	Gutter Lip Ht (in)	N/A	N/A	Gutter X Slope (%)	N/A
N/A	A Painted X Walk1?	No	N/A	Painted X Walk2?	No
	X Walk 1 Direction	To N		X Walk 2 Direction	To W
N/A	X Walk 1 Width (in)	N/A	N/A	X Walk 2 Width (in)	N/A
	X Walk 1 Slope (%)	1.4		X Walk 2 Slope (%)	0.4

X Walk 1 X Slope (%)	0.6		X Walk 2 X Slope (%)	0.7
N/A	A Ramp inside XWalk1?	N/A	N/A	Ramp inside XWalk2?	N/A
	Road Slope (%)	0.9	N/A	Clear Space?	N/A
	Road X Slope (%)	0.2	N/A	Clear Space to XWalk (in)	N/A
N/A	A Any Obstructions?	N/A	N/A	Storm Grate/Utility Hazard?	N/A
	Obstruction Type			Storm Grate/Utility Type	
		N/A			N/A
			Yes	Surface Condition? (G/P)	Good

Remove & Replace Curb Ramp With Two New Directional Ramps or Equivalent.
