Access Compliance Report

Public Rights-of-Way

(Curb Ramps)

Intersection ID: 50269	Main Street: SOUTH_BV	Cross Street: HARTFORD_AV	Location: SE
ADA ID: 4A0213BF84D9	Ramp Type: PerpDiag	Initial Pass/Fail: Fail	Overall Compliance: No
		Severity Score: 8.75

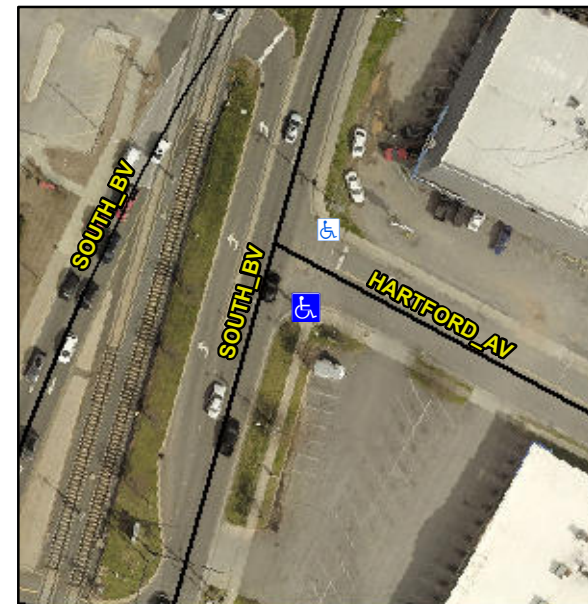
Not Found, R304.5.1

Compliance	Description	Data	Compliance	Description	Data
N/A	Ramp Length (in)	108.0	Yes	Ramp Slope (%)	5.9
No	Ramp Width (in)	47.0	Yes	Ramp XSlope (%)	0.9
N/A	Flare Type LT	N/A	N/A	Flare Type RT	N/A
N/A	Flare Slope LT (%)	N/A	N/A	Flare Slope RT (%)	N/A
N/A	Flare Traversable LT?	N/A	N/A	Flare Traversable RT?	N/A
N/A	Landing Length (in)	N/A	N/A	DWS Provided?	N/A
N/A	Landing Width (in)	N/A	N/A	DWS Contrast?	N/A
N/A	Landing Slope (%)	N/A	N/A	DWS Length (in)	N/A
N/A	Landing X Slope (%)	N/A	N/A	DWS Full Width?	N/A
N/A	Landing Curb? (Y/N)	N/A	N/A	DWS Offset (in)	N/A
N/A	Shared Landing?	N/A			
N/A	Gutter Ponding?	N/A	N/A	Gutter Slope (%)	N/A
N/A	Gutter Lip Ht (in)	N/A	N/A	Gutter X Slope (%)	N/A
N/A	Painted X Walk1?	Yes	N/A	Painted X Walk2?	No
	X Walk 1 Direction	To NE		X Walk 2 Direction	To NW
N/A	X Walk 1 Width (in)	109.0	N/A	X Walk 2 Width (in)	N/A
	X Walk 1 Slope (%)	3.5		X Walk 2 Slope (%)	1.8
	X Walk 1 X Slope (%)	0.7		X Walk 2 X Slope (%)	2.4

N/A	Ramp inside XWalk1?	Yes	N/A	Ramp inside XWalk2?	N/A
	Road Slope (%)	0.7	N/A	Clear Space?	N/A
	Road X Slope (%)	2.4	N/A	Clear Space to XWalk (in)	N/A
N/A	Any Obstructions?	N/A	N/A	Storm Grate/Utility Hazard?	N/A
	Obstruction Type			Storm Grate/Utility Type	
		N/A			N/A
		Yes		Surface Condition? (G/P)	Good

Remove & Replace Curb Ramp With Two New Directional Ramps or Equivalent.
