Access Compliance Report

Public Rights-of-Way

(Curb Ramps)

Intersection ID: 50370	Main Street: GENEVIEVE_CT	Cross Street: COUNTRY_LN	Location: SE
ADA ID: 4A037F8DE4B1	Ramp Type: Perp	Initial Pass/Fail: Fail	Overall Compliance: No
Severity Score: 8.75			
Codes/Mitigation Info/Possible Solution		Field Measurements/Component Compliance

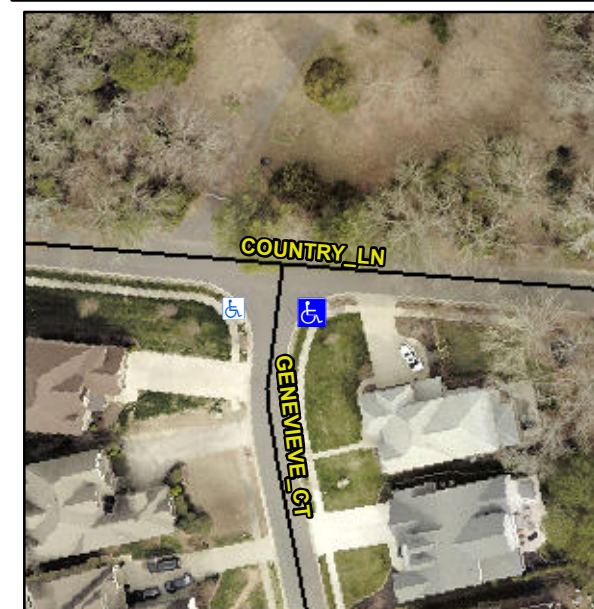
Not Found, R304.5.1

Compliance	Description	Data	Compliance	Description	Data
N/A	Ramp Length (in)	47.0	Yes	Ramp Slope (%)	7.0
No	Ramp Width (in)	45.5	Yes	Ramp XSlope (%)	1.8
N/A	Flare Type LT	N/A	N/A	Flare Type RT	N/A
N/A	Flare Slope LT (%)	N/A	N/A	Flare Slope RT (%)	N/A
N/A	Flare Traversable LT?	N/A	N/A	Flare Traversable RT?	N/A
N/A	Landing Length (in)	N/A	N/A	DWS Provided?	N/A
N/A	Landing Width (in)	N/A	N/A	DWS Contrast?	N/A
N/A	Landing Slope (%)	N/A	N/A	DWS Length (in)	N/A
N/A	Landing X Slope (%)	N/A	N/A	DWS Full Width?	N/A
N/A	Landing Curb? (Y/N)	N/A	N/A	DWS Offset (in)	N/A
N/A	Shared Landing?	N/A			
N/A	Gutter Ponding?	N/A	N/A	Gutter Slope (%)	N/A
N/A	Gutter Lip Ht (in)	N/A	N/A	Gutter X Slope (%)	N/A
N/A	Painted X Walk1?	No	N/A	Painted X Walk2?	N/A
	X Walk 1 Direction	To W		X Walk 2 Direction	N/A
N/A	X Walk 1 Width (in)	N/A	N/A	X Walk 2 Width (in)	N/A
	X Walk 1 Slope (%)	0.2		X Walk 2 Slope (%)	N/A
	X Walk 1 X Slope (%)	2.3		X Walk 2 X Slope (%)	N/A

N/A	Ramp inside XWalk1?	N/A	N/A	Ramp inside XWalk2?	N/A
	Road Slope (%)	N/A	N/A	Clear Space?	N/A
	Road X Slope (%)	N/A	N/A	Clear Space to XWalk (in)	N/A
N/A	Any Obstructions?	N/A	N/A	Storm Grate/Utility Hazard?	N/A
	Obstruction Type			Storm Grate/Utility Type	
		N/A			N/A
			Yes	Surface Condition? (G/P)	Good

Remove & Replace Entire Ramp.
