# Access Compliance Report

## Public Rights-of-Way

### (Curb Ramps)

Intersection ID: 17169	Main Street: IDLEWILD_RD	Cross Street: CEDARS_EAST_CT	Location: SW
ADA ID: 4A0E2E1AEA2C	Ramp Type: Directional1	Initial Pass/Fail: Fail	Overall Compliance: No
Severity Score: 13.75			
Codes/Mitigation Info/Possible Solution		Field Measurements/Component Compliance

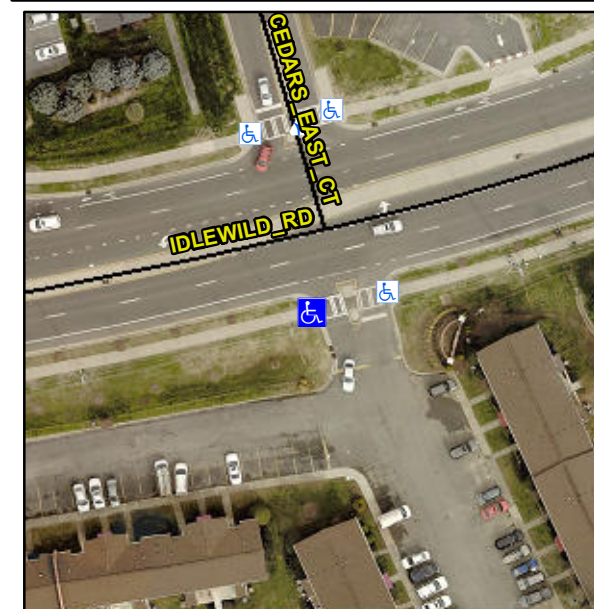
**R304.2.2, R304.5.3**

Compliance	Description	Data	Compliance	Description	Data
N/A	Ramp Length (in)	73.0	N/A	Grade Break?	N/A
Yes	Ramp Width (in)	48.0	N/A	Grade Break Slope (%)	0.0
No	Ramp Slope (%)	10.9	N/A	Grade Break XSlope (%)	0.0
No	Ramp XSlope (%)	2.1			
N/A	Flare Type LT	N/A	N/A	Flare Type RT	N/A
N/A	Flare Slope LT (%)	N/A	N/A	Flare Slope RT (%)	0.0
N/A	Flare Traversable LT?	N/A	N/A	Flare Traversable RT?	N/A
N/A	Landing Length (in)	0.0	N/A	DWS Provided?	N/A
N/A	Landing Width (in)	0.0	N/A	DWS Contrast?	N/A
N/A	Landing Slope (%)	0.0	N/A	DWS Length (in)	N/A
N/A	Landing X Slope (%)	0.0	N/A	DWS Full Width?	N/A
N/A	Landing Curb? (Y/N)	N/A	N/A	DWS Offset LT (in)	N/A
N/A	Shared Landing?	N/A	N/A	DWS Offset RT (in)	N/A
N/A	Gutter Ponding?	0.0	N/A	Gutter Slope (%)	N/A
N/A	Gutter Lip Ht (in)	0.0	N/A	Gutter X Slope (%)	N/A
N/A	Painted X Walk1?	Yes		Road Slope (%)	1.3
	X Walk 1 Direction	To E		Road X Slope (%)	1.0
	X Walk 1 Width (in)	112.0		Clear Space?	N/A

X Walk 1 Slope (%)	1.3	N/A	Clear Space to XWalk (in)	N/A
	X Walk 1 X Slope (%)	1.0	N/A	Storm Grate/Utility Hazard?	N/A
N/A	Ramp inside XWalk1?	Yes		Storm Grate/Utility Type	
N/A	Any Obstructions?	N/A			N/A
	Obstruction Type		Yes	Surface Condition? (G/P)	Good
			N/A	Curb Slope (%)	9.7

**Remove & Replace Entire Ramp.**

Total Cost: \$ 1600.00
