Access Compliance Report

Public Rights-of-Way

(Curb Ramps)

Intersection ID: 18066	Main Street: CHARMAPEG_AV	Cross Street: LYTTLETON_DR	Location: SW
ADA ID: 4A1128E22DAB	Ramp Type: PerpDiag	Initial Pass/Fail: Fail	Overall Compliance: No
Severity Score: 13.75			
Codes/Mitigation Info/Possible Solution		Field Measurements/Component Compliance

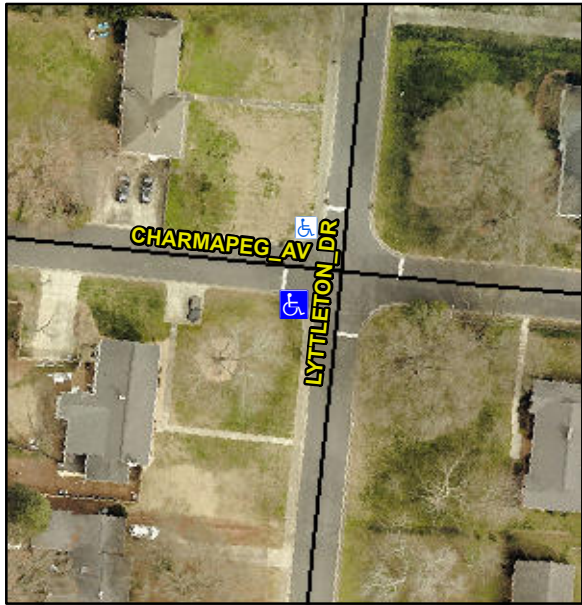
Compliance	Description	Data	Compliance	Description	Data
N/A	Ramp Length (in)	50.0	No	Ramp Slope (%)	9.5
Yes	Ramp Width (in)	48.0	No	Ramp XSlope (%)	4.5
N/A	Flare Type LT	N/A	N/A	Flare Type RT	N/A
N/A	Flare Slope LT (%)	N/A	N/A	Flare Slope RT (%)	N/A
N/A	Flare Traversable LT?	N/A	N/A	Flare Traversable RT?	N/A
N/A	Landing Length (in)	N/A	N/A	DWS Provided?	N/A
N/A	Landing Width (in)	N/A	N/A	DWS Contrast?	N/A
N/A	Landing Slope (%)	N/A	N/A	DWS Length (in)	N/A
N/A	Landing X Slope (%)	N/A	N/A	DWS Full Width?	N/A
N/A	Landing Curb? (Y/N)	N/A	N/A	DWS Offset (in)	N/A
N/A	Shared Landing?	N/A			
N/A	Gutter Ponding?	N/A	N/A	Gutter Slope (%)	N/A
N/A	Gutter Lip Ht (in)	N/A	N/A	Gutter X Slope (%)	N/A
N/A	Painted X Walk1?	No	N/A	Painted X Walk2?	No
	X Walk 1 Direction	To SE		X Walk 2 Direction	To NE
N/A	X Walk 1 Width (in)	N/A	N/A	X Walk 2 Width (in)	N/A
	X Walk 1 Slope (%)	3.5		X Walk 2 Slope (%)	3.4
	X Walk 1 X Slope (%)	1.8		X Walk 2 X Slope (%)	7.0

N/A	Ramp inside XWalk1?	N/A	N/A	Ramp inside XWalk2?	N/A
	Road Slope (%)	4.0	N/A	Clear Space?	N/A
	Road X Slope (%)	6.7	N/A	Clear Space to XWalk (in)	N/A
N/A	Any Obstructions?	N/A	N/A	Storm Grate/Utility Hazard?	N/A
	Obstruction Type			Storm Grate/Utility Type	
		N/A			N/A
			Yes	Surface Condition? (G/P)	Good

Possible Solutions:					
	Remove & Replace Curb Ramp With Two New Directional Ramps or Equivalent.					
	Surveyor Notes:					
	N/A					
	PROW/ADA:					
	Not Found, R304.2.2, R304.5.3					
Street 1 Name	LYTTLETON DR					
Stop Condition-Street 2	StopSign					
Street 2 Name	CHARMAPEG AV					
Stop Condition-Street 1	StopSign					
Total Cost:		\$	3200.00
