## Access Compliance Report Public Rights-of-Way (Curb Ramps)

Intersection ID: 46371 Main Street: SIR\_CHARLES\_PL Cross Street: STRONVAR\_HOUSE\_LN Location: NE

ADA ID: 4A29ABC4D344 Ramp Type: PerpDiag Initial Pass/Fail: Fail Overall Compliance: No Severity Score: 21.25

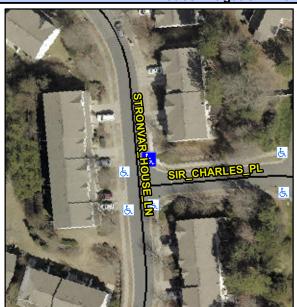
PROW/ADA:
Not Found, R304.5.1, R304.2.2

Field Measurements/Component Compliance						
	Comp	liance Description	Data	Comp	liance Description	Data
	N/A	Ramp Length (in)	49.0	No	Ramp Slope (%)	8.5
	No	Ramp Width (in)	43.0	Yes	Ramp XSlope (%)	2.0
	N/A	Flare Type LT	N/A	N/A	Flare Type RT	N/A
	N/A	Flare Slope LT (%)	N/A	N/A	Flare Slope RT (%)	N/A
	N/A	Flare Traversable LT?	N/A	N/A	Flare Traversable RT?	N/A
	N/A	Landing Length (in)	N/A	N/A	DWS Provided?	N/A
	N/A	Landing Width (in)	N/A	N/A	DWS Contrast?	N/A
	N/A	Landing Slope (%)	N/A	N/A	DWS Length (in)	N/A
	N/A	Landing X Slope (%)	N/A	N/A	DWS Full Width?	N/A
	N/A	Landing Curb? (Y/N)	N/A	N/A	DWS Offset (in)	N/A
	N/A	Shared Landing?	N/A			
	N/A	Gutter Ponding?	N/A	N/A	Gutter Slope (%)	N/A
	N/A	Gutter Lip Ht (in)	N/A	N/A	Gutter X Slope (%)	N/A
	N/A	Painted X Walk1?	No	N/A	Painted X Walk2?	No
		X Walk 1 Direction	To SW		X Walk 2 Direction	To S
	N/A	X Walk 1 Width (in)	N/A	N/A	X Walk 2 Width (in)	N/A
		X Walk 1 Slope (%)	1.8		X Walk 2 Slope (%)	0.1

Remove & Replace Curb Ramp With
Two New Directional Ramps or
Equivalent.
