Access Compliance Report

Public Rights-of-Way

(Curb Ramps)

Intersection ID: 50998	Main Street: S_TRYON_ST	Cross Street: STELECROFT_PY	Location: NE
ADA ID: 4A35C478A34C	Ramp Type: Perp	Initial Pass/Fail: Fail	Overall Compliance: No
Severity Score: 22.5			
Codes/Mitigation Info/Possible Solution		Field Measurements/Component Compliance

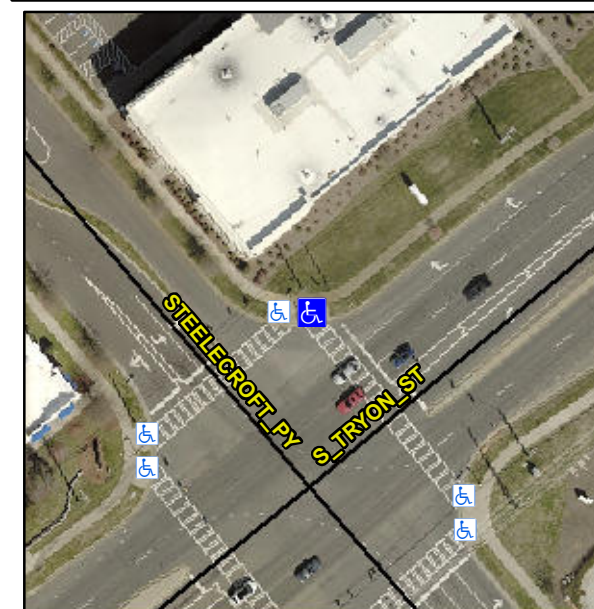
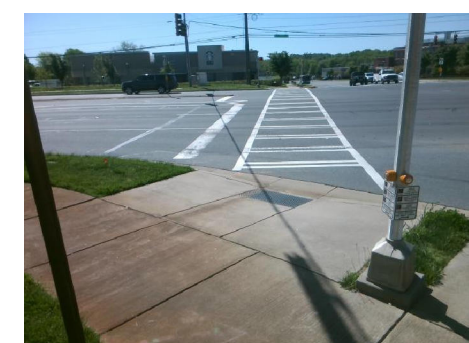
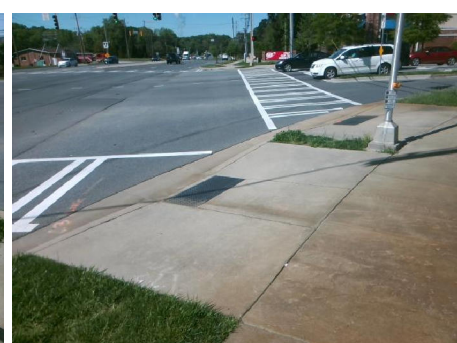
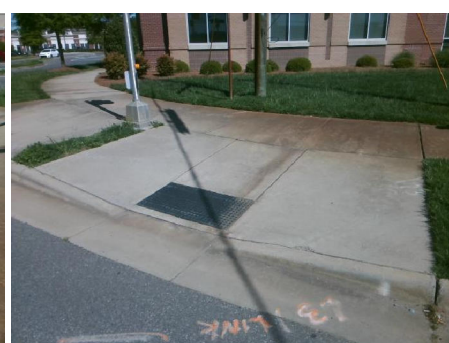
R304.5.1, R304.2.2, R304.5.3

Compliance	Description	Data	Compliance	Description	Data
N/A	Ramp Length (in)	95.0	No	Ramp Slope (%)	9.9
No	Ramp Width (in)	46.5	No	Ramp XSlope (%)	3.6
N/A	Flare Type LT	N/A	N/A	Flare Type RT	N/A
N/A	Flare Slope LT (%)	N/A	N/A	Flare Slope RT (%)	N/A
N/A	Flare Traversable LT?	N/A	N/A	Flare Traversable RT?	N/A
N/A	Landing Length (in)	N/A	N/A	DWS Provided?	N/A
N/A	Landing Width (in)	N/A	N/A	DWS Contrast?	N/A
N/A	Landing Slope (%)	N/A	N/A	DWS Length (in)	N/A
N/A	Landing X Slope (%)	N/A	N/A	DWS Full Width?	N/A
N/A	Landing Curb? (Y/N)	N/A	N/A	DWS Offset (in)	N/A
N/A	Shared Landing?	N/A			
N/A	Gutter Ponding?	N/A	N/A	Gutter Slope (%)	N/A
N/A	Gutter Lip Ht (in)	N/A	N/A	Gutter X Slope (%)	N/A
N/A	Painted X Walk1?	Yes	N/A	Painted X Walk2?	N/A
	X Walk 1 Direction	To SE		X Walk 2 Direction	N/A
N/A	X Walk 1 Width (in)	111.0	N/A	X Walk 2 Width (in)	N/A
	X Walk 1 Slope (%)	1.6		X Walk 2 Slope (%)	N/A
	X Walk 1 X Slope (%)	1.5		X Walk 2 X Slope (%)	N/A

N/A	Ramp inside XWalk1?	Yes	N/A	Ramp inside XWalk2?	N/A
	Road Slope (%)	N/A	N/A	Clear Space?	N/A
	Road X Slope (%)	N/A	N/A	Clear Space to XWalk (in)	N/A
N/A	Any Obstructions?	N/A	N/A	Storm Grate/Utility Hazard?	N/A
	Obstruction Type			Storm Grate/Utility Type	
		N/A			N/A
			Yes	Surface Condition? (G/P)	Good

Remove & Replace Entire Ramp.

Total Cost: \$ 1850.00
