# Access Compliance Report

## Public Rights-of-Way

### (Curb Ramps)

Intersection ID: 49388	Main Street: SHORTHORN_ST	Cross Street: DAMASCUS_ST	Location: NW
ADA ID: 4A3C0FD65518	Ramp Type: PerpDiag	Initial Pass/Fail: Fail	Overall Compliance: No
Codes/Mitigation Info/Possible Solution		Field Measurements/Component Compliance

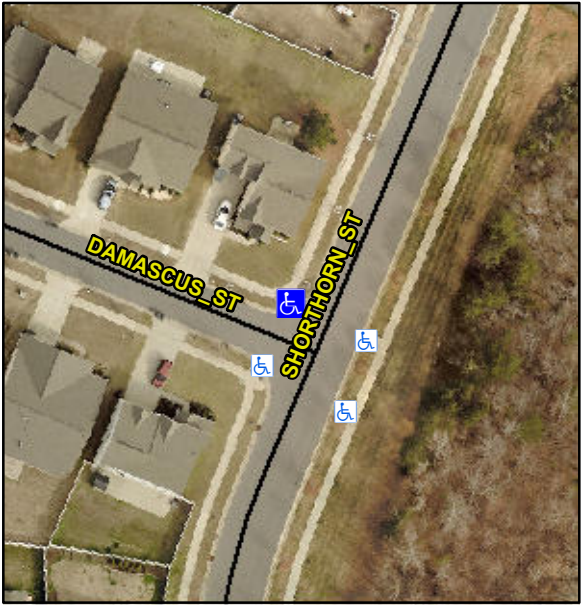
Possible Solutions:	Compliance	Description	Data	Compliance	Description	Data
	Remove & Replace Curb Ramp With Two New Directional Ramps or Equivalent.	N/A	Ramp Length (in)	71.0	No	Ramp Slope (%)	10.4
<p>Surveyor Notes:</p> <p>N/A</p> <p>PROW/ADA:</p> <p>Not Found, R304.5.1, R304.2.2, R304.5.3</p>		No	Ramp Width (in)	47.5	No	Ramp XSlope (%)	6.7
		N/A	Flare Type LT	N/A	N/A	Flare Type RT	N/A
		N/A	Flare Slope LT (%)	N/A	N/A	Flare Slope RT (%)	N/A
		N/A	Flare Traversable LT?	N/A	N/A	Flare Traversable RT?	N/A
		N/A	Landing Length (in)	N/A	N/A	DWS Provided?	N/A
		N/A	Landing Width (in)	N/A	N/A	DWS Contrast?	N/A
		N/A	Landing Slope (%)	N/A	N/A	DWS Length (in)	N/A
		N/A	Landing X Slope (%)	N/A	N/A	DWS Full Width?	N/A
		N/A	Landing Curb? (Y/N)	N/A	N/A	DWS Offset (in)	N/A
		N/A	Shared Landing?	N/A			
		N/A	Gutter Ponding?	N/A	N/A	Gutter Slope (%)	N/A
		N/A	Gutter Lip Ht (in)	N/A	N/A	Gutter X Slope (%)	N/A
		N/A	Painted X Walk1?	No	N/A	Painted X Walk2?	No

X Walk 1 Direction	To SW		X Walk 2 Direction	To SE
		N/A	X Walk 1 Width (in)	N/A	N/A	X Walk 2 Width (in)	N/A
			X Walk 1 Slope (%)	3.0		X Walk 2 Slope (%)	1.3
			X Walk 1 X Slope (%)	2.8		X Walk 2 X Slope (%)	5.3
		N/A	Ramp inside XWalk1?	N/A	N/A	Ramp inside XWalk2?	N/A
			Road Slope (%)	6.2	N/A	Clear Space?	N/A
			Road X Slope (%)	2.7	N/A	Clear Space to XWalk (in)	N/A
		N/A	Any Obstructions?	N/A	N/A	Storm Grate/Utility Hazard?	N/A
			Obstruction Type			Storm Grate/Utility Type	
				N/A			N/A
					Yes	Surface Condition? (G/P)	Good
