Access Compliance Report Public Rights-of-Way (Curb Ramps)

Intersection ID: 48492 Main Street: SHOPTON_RD_WEST Cross Street: BEREWICK_COMMONS_PY Location: NW
ADA ID: 4A3F48742C0A Ramp Type: Perp Initial Pass/Fail: Fail Overall Compliance: No Severity Score: 12.5

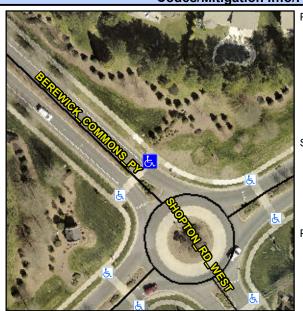
Not Found, R304.2.2

No N/A Ramp Length (in) 70.0 Ramp Slope (%) 9.6 Ramp XSlope (%) Yes Ramp Width (in) 48.0 Yes 1.2 N/A N/A Flare Type LT N/A Flare Type RT N/A N/A N/A Flare Slope RT (%) N/A Flare Slope LT (%) N/A N/A Flare Traversable LT? N/A N/A Flare Traversable RT? N/A N/A N/A N/A DWS Provided? N/A Landing Length (in) N/A Landing Width (in) N/A N/A **DWS Contrast?** N/A N/A N/A Landing Slope (%) N/A DWS Length (in) N/A N/A Landing X Slope (%) N/A N/A DWS Full Width? N/A N/A Landing Curb? (Y/N) N/A N/A DWS Offset (in) N/A N/A Shared Landing? **Gutter Ponding?** N/A N/A Gutter Slope (%) N/A Gutter Lip Ht (in) N/A N/A Gutter X Slope (%) N/A Painted X Walk1? Yes N/A Painted X Walk2? N/A X Walk 1 Direction To SW X Walk 2 Direction N/A 98.0 X Walk 1 Width (in) X Walk 2 Width (in) N/A X Walk 1 Slope (%) X Walk 2 Slope (%) N/A 3.1 X Walk 1 X Slope (%) 1.2 X Walk 2 X Slope (%) N/A N/A Ramp inside XWalk2? Ramp inside XWalk1? Yes N/A Road Slope (%) N/A N/A Clear Space? N/A Road X Slope (%) N/A N/A Clear Space to XWalk (in) N/A N/A Any Obstructions? N/A Storm Grate/Utility Hazard? N/A **Obstruction Type** Storm Grate/Utility Type N/A N/A Yes Surface Condition? (G/P) Good

Remove & Replace Entire Ramp.
