Intersection ID: N/A	Main Street: SUMMERFIELD RIDGE LN	Cross Street: CALABASSAS LN	Location:	SW
ADA ID: 4A5263120F64	Ramp Type: PerpDiag	Initial Pass/Fail: Fail	Overall Compliance: No	Severity Score: 21.25

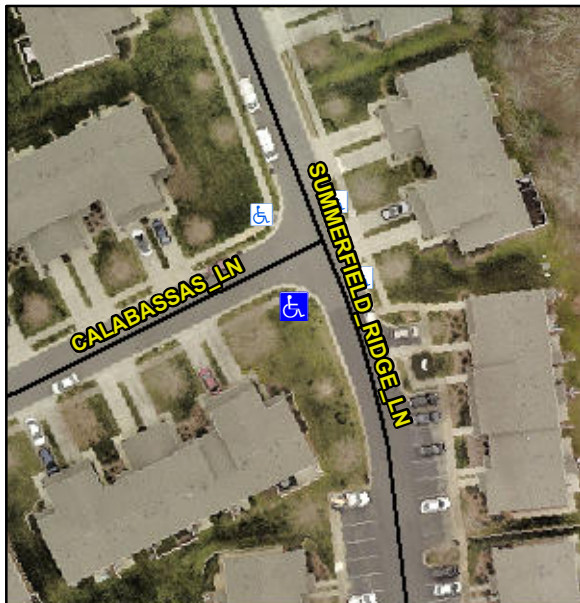
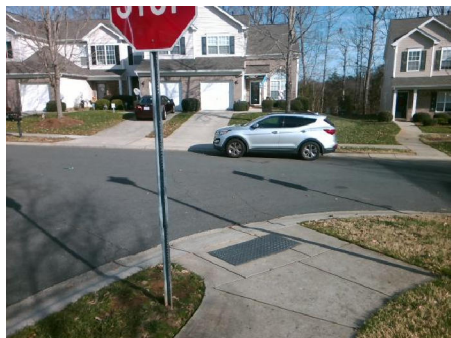
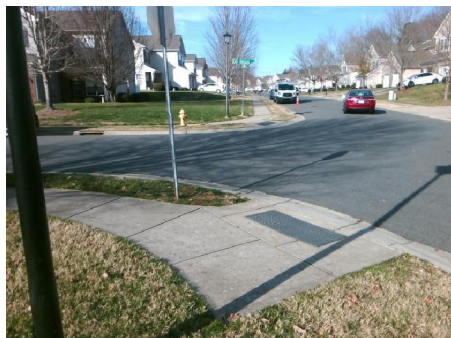
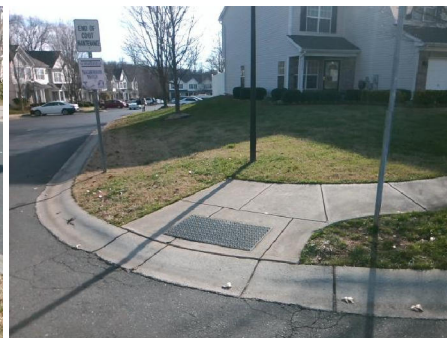
Possible Solutions:		Remove & Replace Curb Ramp With Two New Directional Ramps or Equivalent.			Compliance	Description	Data	Compliance	Description	Data
	Surveyor Notes:		N/A			N/A	Ramp Length (in)	44.0	Yes	Ramp Slope (%)	6.8
	PROW/ADA:		Not Found, R304.5.1, R304.5.3			No	Ramp Width (in)	42.5	No	Ramp XSlope (%)	5.5
						N/A	Flare Type LT	N/A	N/A	Flare Type RT	N/A
						N/A	Flare Slope LT (%)	N/A	N/A	Flare Slope RT (%)	N/A
						N/A	Flare Traversable LT?	No	N/A	Flare Traversable RT?	No
						N/A	Landing Length (in)	N/A	N/A	DWS Provided?	N/A
						N/A	Landing Width (in)	N/A	N/A	DWS Contrast?	N/A
						N/A	Landing Slope (%)	N/A	N/A	DWS Length (in)	N/A
						N/A	Landing X Slope (%)	N/A	N/A	DWS Full Width?	N/A
					N/A	Landing Curb? (Y/N)	N/A	N/A	DWS Offset (in)	N/A	
					N/A	Shared Landing?	N/A				
					N/A	Gutter Ponding?	N/A	N/A	Gutter Slope (%)	N/A	N/A

N/A	Gutter Lip Ht (in)	N/A	N/A	Gutter X Slope (%)	N/A	N/A
					N/A	Painted X Walk1?	No	N/A	Painted X Walk2?	No	No
						X Walk 1 Direction	To E		X Walk 2 Direction	To N	To N
					N/A	X Walk 1 Width (in)	N/A	N/A	X Walk 2 Width (in)	N/A	N/A
						X Walk 1 Slope (%)	0.2		X Walk 2 Slope (%)	6.1	6.1
						X Walk 1 X Slope (%)	7.2		X Walk 2 X Slope (%)	0.3	0.3
					N/A	Ramp inside XWalk1?	N/A	N/A	Ramp inside XWalk2?	N/A	N/A
						Road Slope (%)	5.9	N/A	Clear Space?	N/A	N/A
						Road X Slope (%)	1.5	N/A	Clear Space to XWalk (in)	N/A	N/A
					N/A	Any Obstructions?	N/A	N/A	Storm Grate/Utility Hazard?	N/A	N/A
						Obstruction Type			Storm Grate/Utility Type		
							N/A			N/A	N/A
								Yes	Surface Condition? (G/P)	Good	Good
Total Cost:			\$	3200.00
