Access Compliance Report Public Rights-of-Way (Curb Ramps)

0					1	011/		
Intersection ID: 23784	Main Street: E_WESTINGHOUSE_BV			Cross Street: NATIONS_FORD_RD				Location:	SW
ADA ID: 4A6D36171CC6	D36171CC6 Ramp Type: Perp			Initial Pass/Fail: Fail Overall Compliance: No				o Severity Score:	13.75
Codes/Mitigation Info/Possible Solution				Field Measurements/Component Compliance					
	1-1	Possible Solutions:		Compliance Description			Data Compliance Description		Data
a for after stiller a	K MA L	Remove & Replace Entire Ram	0.	N/A	Ramp Length (in)	120.0	No	Ramp Slope (%)	10.7
a some can for				Yes	Ramp Width (in)	48.0	No	Ramp XSlope (%)	4.0
	21 Jail			N/A	Flare Type LT	N/A	N/A	Flare Type RT	N/A
WESTIMON				N/A	Flare Slope LT (%)	N/A	N/A	Flare Slope RT (%)	N/A
SUCHOUSE SW				N/A	Flare Traversable LT?	N/A	N/A	Flare Traversable RT?	N/A
and the second	A 711 -5			N/A	Landing Length (in)	N/A	N/A	DWS Provided?	N/A
	57-1-	Surveyor Notes:		N/A	Landing Width (in)	N/A	N/A	DWS Contrast?	N/A

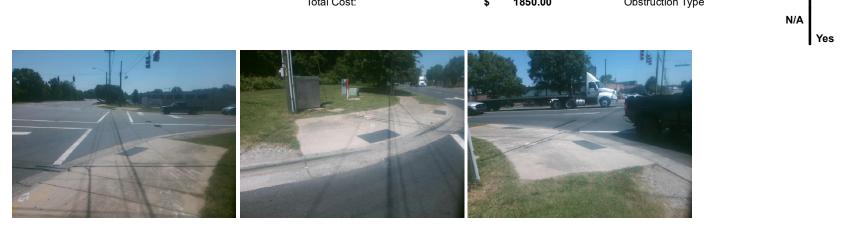
Barrier Barr		N/A		N/A	Landing Slope (%)	N/A	N/A	DWS Length (in)	N/A
Station to 1	6			N/A	Landing X Slope (%)	N/A	N/A	DWS Full Width?	N/A
8	A A			N/A	Landing Curb? (Y/N)	N/A	N/A	DWS Offset (in)	N/A
	100 1.			N/A	Shared Landing?	N/A			
	Real Hills	PROW/ADA:		N/A	Gutter Ponding?	N/A	N/A	Gutter Slope (%)	N/A
		Not Found, R304.2.2, R304.5.3		N/A	Gutter Lip Ht (in)	N/A	N/A	Gutter X Slope (%)	N/A
		, ,		N/A	Painted X Walk1?	Yes	N/A	Painted X Walk2?	N/A

-			X Walk 1 Direction	To SE		X Walk 2 Direction	N/A
			N/A	X Walk 1 Width (in)	98.0	N/A	X Walk 2 Width (in)	N/A	
Street 1 Name N	ATIONS FORD RD				X Walk 1 Slope (%)	0.8		X Walk 2 Slope (%)	N/A
Stop Condition-Street 2	Signal				X Walk 1 X Slope (%)	2.8		X Walk 2 X Slope (%)	N/A
Street 2 Name	N/A			N/A	Ramp inside XWalk1?	Yes	N/A	Ramp inside XWalk2?	N/A
Stop Condition-Street 1	N/A				Road Slope (%)	N/A	N/A	Clear Space?	N/A
					Road X Slope (%)	N/A	N/A	Clear Space to XWalk (in)	N/A
				N/A	Any Obstructions?	N/A	N/A	Storm Grate/Utility Hazard?	N/A
		Total Cost: \$	1850.00		Obstruction Type			Storm Grate/Utility Type	
						N/A			N/A
