Access Compliance Report

Public Rights-of-Way

(Curb Ramps)

Intersection ID: 50998	Main Street: S_TRYON_ST	Cross Street: STEELECROFT_PY	Location: S
ADA ID: 4A6D50177D35	Ramp Type: Perp	Initial Pass/Fail: Fail	Overall Compliance: No
Severity Score: 12.5			
Codes/Mitigation Info/Possible Solution		Field Measurements/Component Compliance

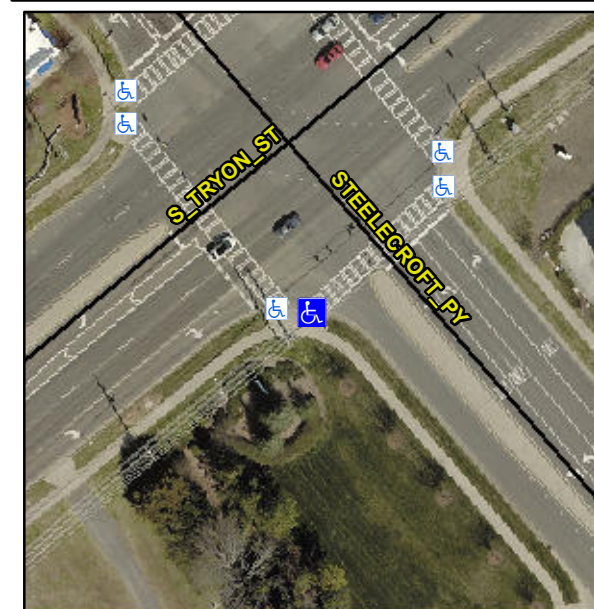
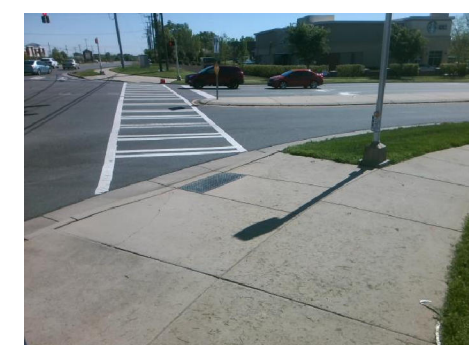
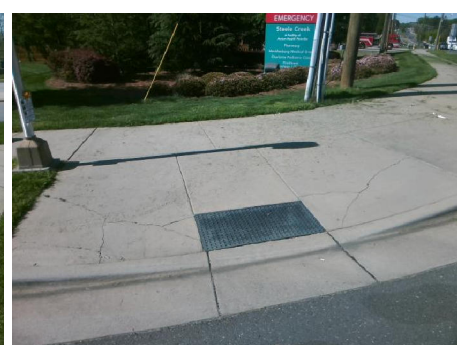
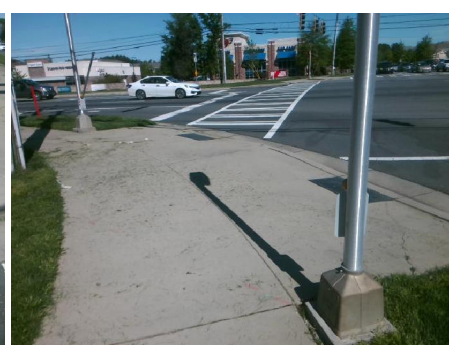
Not Found, R304.5.3

Compliance	Description	Data	Compliance	Description	Data
N/A	Ramp Length (in)	96.0	Yes	Ramp Slope (%)	6.8
Yes	Ramp Width (in)	48.0	No	Ramp XSlope (%)	6.2
N/A	Flare Type LT	N/A	N/A	Flare Type RT	N/A
N/A	Flare Slope LT (%)	N/A	N/A	Flare Slope RT (%)	N/A
N/A	Flare Traversable LT?	N/A	N/A	Flare Traversable RT?	N/A
N/A	Landing Length (in)	N/A	N/A	DWS Provided?	N/A
N/A	Landing Width (in)	N/A	N/A	DWS Contrast?	N/A
N/A	Landing Slope (%)	N/A	N/A	DWS Length (in)	N/A
N/A	Landing X Slope (%)	N/A	N/A	DWS Full Width?	N/A
N/A	Landing Curb? (Y/N)	N/A	N/A	DWS Offset (in)	N/A
N/A	Shared Landing?	N/A			
N/A	Gutter Ponding?	N/A	N/A	Gutter Slope (%)	N/A
N/A	Gutter Lip Ht (in)	N/A	N/A	Gutter X Slope (%)	N/A
N/A	Painted X Walk1?	Yes	N/A	Painted X Walk2?	N/A
	X Walk 1 Direction	To NE		X Walk 2 Direction	N/A
N/A	X Walk 1 Width (in)	112.0	N/A	X Walk 2 Width (in)	N/A
	X Walk 1 Slope (%)	0.6		X Walk 2 Slope (%)	N/A
	X Walk 1 X Slope (%)	4.0		X Walk 2 X Slope (%)	N/A

N/A	Ramp inside XWalk1?	Yes	N/A	Ramp inside XWalk2?	N/A
	Road Slope (%)	N/A	N/A	Clear Space?	N/A
	Road X Slope (%)	N/A	N/A	Clear Space to XWalk (in)	N/A
N/A	Any Obstructions?	N/A	N/A	Storm Grate/Utility Hazard?	N/A
	Obstruction Type			Storm Grate/Utility Type	
		N/A			N/A
		Yes		Surface Condition? (G/P)	Good

Remove & Replace Entire Ramp.
