Access Compliance Report

Public Rights-of-Way

(Curb Ramps)

| Intersection ID: 14792 | Main Street: RANDOLPH_RD | Cross Street: VAN_NESS_ST | Location: NE |

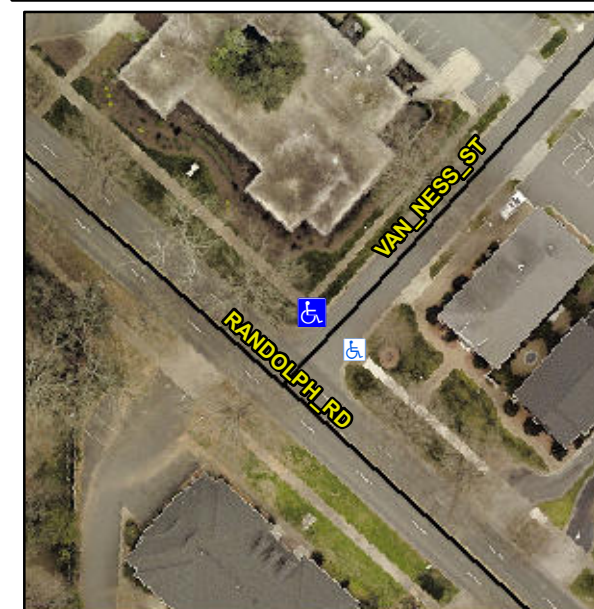
| ADA ID: 4A6F2E1634FD | Ramp Type: Perp | Initial Pass/Fail: Fail | Overall Compliance: No |
| Severity Score: 21.25 | | | |

Not Found, R304.5.1, R304.2.2

| Compliance | Description | Data | Compliance | Description | Data |
|---|---|---|---|---|---|
| N/A | Ramp Length (in) | 79.0 | No | Ramp Slope (%) | 9.8 |
| No | Ramp Width (in) | 46.0 | Yes | Ramp XSlope (%) | 1.7 |

Possible Solutions:

Remove & Replace Entire Ramp.
