# Access Compliance Report

## Public Rights-of-Way

### (Curb Ramps)

Intersection ID: N/A	Main Street: HOOVER_CREEK_BV	Cross Street: N/A	Location: NE
ADA ID: 4A8AB7C5894C	Ramp Type: PerpDiag	Initial Pass/Fail: Fail	Overall Compliance: No
Severity Score: 8.75			
Codes/Mitigation Info/Possible Solution		Field Measurements/Component Compliance

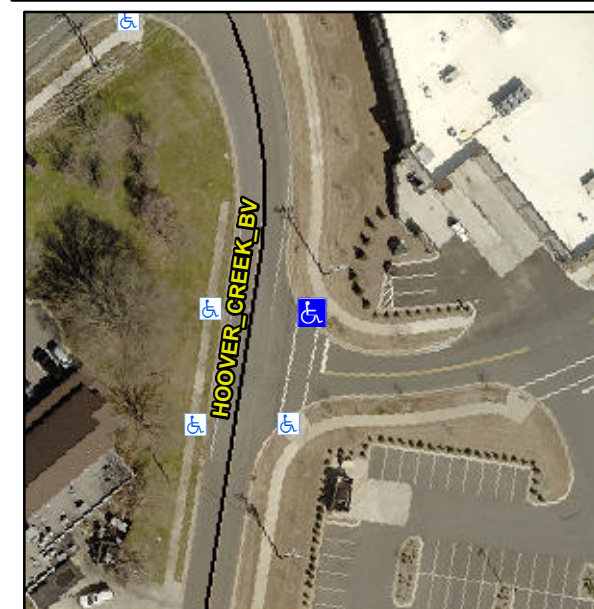
**Not Found, R304.5.1**

Compliance	Description	Data	Compliance	Description	Data
N/A	Ramp Length (in)	95.0	Yes	Ramp Slope (%)	7.9
No	Ramp Width (in)	44.0	Yes	Ramp XSlope (%)	0.8
N/A	Flare Type LT	N/A	N/A	Flare Type RT	N/A
N/A	Flare Slope LT (%)	N/A	N/A	Flare Slope RT (%)	N/A
N/A	Flare Traversable LT?	N/A	N/A	Flare Traversable RT?	N/A
N/A	Landing Length (in)	N/A	N/A	DWS Provided?	N/A
N/A	Landing Width (in)	N/A	N/A	DWS Contrast?	N/A
N/A	Landing Slope (%)	N/A	N/A	DWS Length (in)	N/A
N/A	Landing X Slope (%)	N/A	N/A	DWS Full Width?	N/A
N/A	Landing Curb? (Y/N)	N/A	N/A	DWS Offset (in)	N/A
N/A	Shared Landing?	N/A			
N/A	Gutter Ponding?	N/A	N/A	Gutter Slope (%)	N/A
N/A	Gutter Lip Ht (in)	N/A	N/A	Gutter X Slope (%)	N/A
N/A	Painted X Walk1?	No	N/A	Painted X Walk2?	Yes
	X Walk 1 Direction	To NW		X Walk 2 Direction	To SW
N/A	X Walk 1 Width (in)	N/A	N/A	X Walk 2 Width (in)	122.0
	X Walk 1 Slope (%)	0.6		X Walk 2 Slope (%)	1.3
	X Walk 1 X Slope (%)	2.5		X Walk 2 X Slope (%)	0.5

N/A	Ramp inside XWalk1?	N/A	N/A	Ramp inside XWalk2?	Yes
	Road Slope (%)	1.4	N/A	Clear Space?	N/A
	Road X Slope (%)	0.1	N/A	Clear Space to XWalk (in)	N/A
N/A	Any Obstructions?	N/A	N/A	Storm Grate/Utility Hazard?	N/A
	Obstruction Type			Storm Grate/Utility Type	
		N/A			N/A
			Yes	Surface Condition? (G/P)	Good

**Remove & Replace Curb Ramp With Two New Directional Ramps or Equivalent.**

Total Cost: \$ 3200.00
