Access Compliance Report

Public Rights-of-Way

(Curb Ramps)

Intersection ID: 5609	Main Street: HAMILTON_CR	Cross Street: SUNSET_RD	Location: NE
ADA ID: 4A907A9775F7	Ramp Type: Perp	Initial Pass/Fail: Fail	Overall Compliance: No
Severity Score: 21.25			
Codes/Mitigation Info/Possible Solution		Field Measurements/Component Compliance

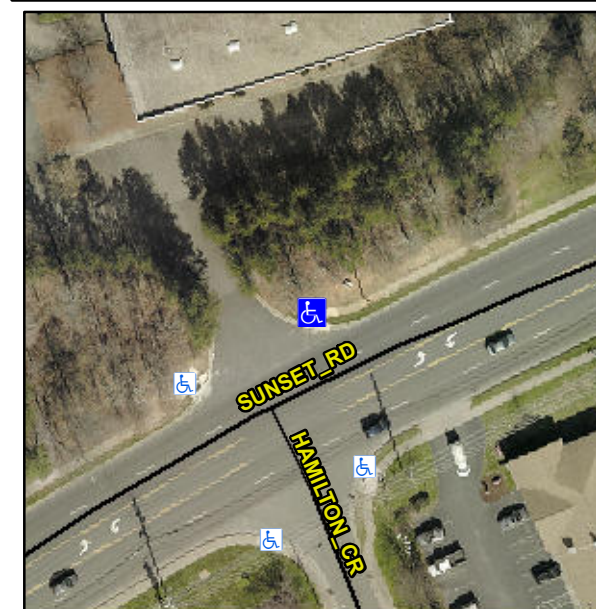
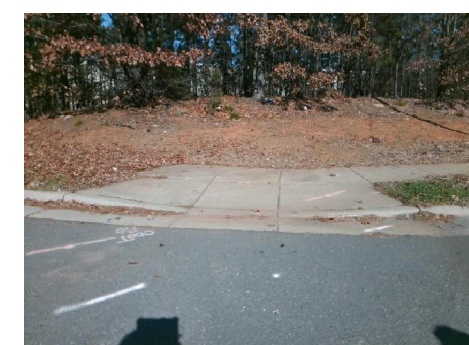
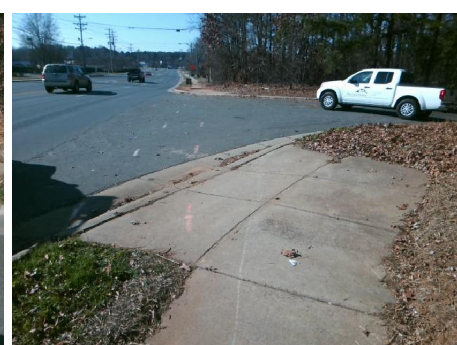
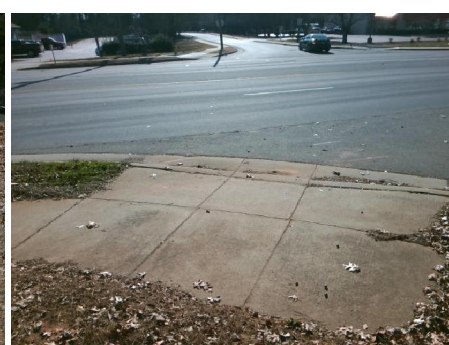
Compliance	Description	Data	Compliance	Description	Data
N/A	Ramp Length (in)	49.5	No	Ramp Slope (%)	8.7
No	Ramp Width (in)	45.0	Yes	Ramp XSlope (%)	0.8
N/A	Flare Type LT	N/A	N/A	Flare Type RT	N/A
N/A	Flare Slope LT (%)	N/A	N/A	Flare Slope RT (%)	N/A
N/A	Flare Traversable LT?	N/A	N/A	Flare Traversable RT?	N/A
N/A	Landing Length (in)	N/A	N/A	DWS Provided?	N/A
N/A	Landing Width (in)	N/A	N/A	DWS Contrast?	N/A
N/A	Landing Slope (%)	N/A	N/A	DWS Length (in)	N/A
N/A	Landing X Slope (%)	N/A	N/A	DWS Full Width?	N/A
N/A	Landing Curb? (Y/N)	N/A	N/A	DWS Offset (in)	N/A
N/A	Shared Landing?	N/A			
N/A	Gutter Ponding?	N/A	N/A	Gutter Slope (%)	N/A
N/A	Gutter Lip Ht (in)	N/A	N/A	Gutter X Slope (%)	N/A
N/A	Painted X Walk1?	No	N/A	Painted X Walk2?	N/A
	X Walk 1 Direction	To S		X Walk 2 Direction	N/A
N/A	X Walk 1 Width (in)	N/A	N/A	X Walk 2 Width (in)	N/A
	X Walk 1 Slope (%)	0.9		X Walk 2 Slope (%)	N/A
	X Walk 1 X Slope (%)	4.0		X Walk 2 X Slope (%)	N/A

N/A	Ramp inside XWalk1?	N/A	N/A	Ramp inside XWalk2?	N/A
	Road Slope (%)	N/A	N/A	Clear Space?	N/A
	Road X Slope (%)	N/A	N/A	Clear Space to XWalk (in)	N/A
N/A	Any Obstructions?	N/A	N/A	Storm Grate/Utility Hazard?	N/A
	Obstruction Type			Storm Grate/Utility Type	
		N/A			N/A
			Yes	Surface Condition? (G/P)	Good

Remove & Replace Entire Ramp.

R304.5.1, R304.2.2
