# Access Compliance Report

## Public Rights-of-Way

### (Curb Ramps)

Intersection ID: N/A	Main Street: AMITY_PL	Cross Street: FARMINGDALE_DR	Location: SW
ADA ID: 4A960AE4CFDE	Ramp Type: PerpDiag	Initial Pass/Fail: Fail	Overall Compliance: No
Severity Score: 10			
Codes/Mitigation Info/Possible Solution		Field Measurements/Component Compliance

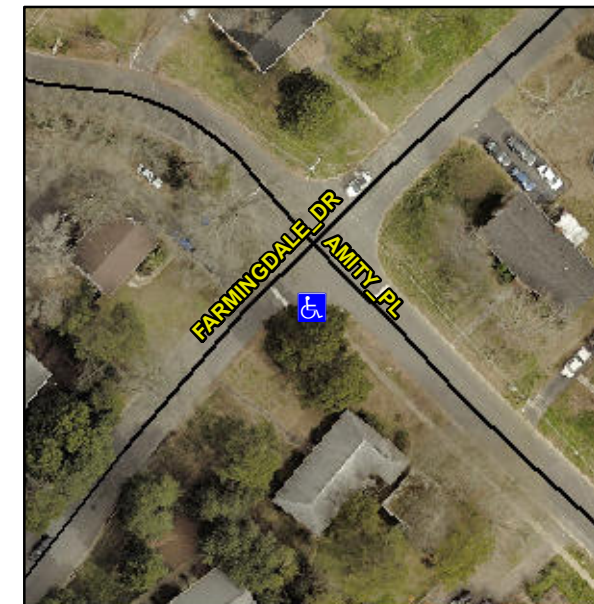
**Not Found, R304.5.1, R304.5.3**

Compliance	Description	Data	Compliance	Description	Data
N/A	Ramp Length (in)	35.0	Yes	Ramp Slope (%)	6.5
No	Ramp Width (in)	47.0	No	Ramp XSlope (%)	4.2
N/A	Flare Type LT	N/A	N/A	Flare Type RT	N/A
N/A	Flare Slope LT (%)	N/A	N/A	Flare Slope RT (%)	N/A
N/A	Flare Traversable LT?	N/A	N/A	Flare Traversable RT?	N/A
N/A	Landing Length (in)	N/A	N/A	DWS Provided?	N/A
N/A	Landing Width (in)	N/A	N/A	DWS Contrast?	N/A
N/A	Landing Slope (%)	N/A	N/A	DWS Length (in)	N/A
N/A	Landing X Slope (%)	N/A	N/A	DWS Full Width?	N/A
N/A	Landing Curb? (Y/N)	N/A	N/A	DWS Offset (in)	N/A
N/A	Shared Landing?	N/A			
N/A	Gutter Ponding?	N/A	N/A	Gutter Slope (%)	N/A
N/A	Gutter Lip Ht (in)	N/A	N/A	Gutter X Slope (%)	N/A
N/A	Painted X Walk1?	No	N/A	Painted X Walk2?	No
	X Walk 1 Direction	To NE		X Walk 2 Direction	To NW
N/A	X Walk 1 Width (in)	N/A	N/A	X Walk 2 Width (in)	N/A
	X Walk 1 Slope (%)	0.1		X Walk 2 Slope (%)	1.3
	X Walk 1 X Slope (%)	2.3		X Walk 2 X Slope (%)	0.0

N/A	Ramp inside XWalk1?	N/A	N/A	Ramp inside XWalk2?	N/A
	Road Slope (%)	1.3	N/A	Clear Space?	N/A
	Road X Slope (%)	1.9	N/A	Clear Space to XWalk (in)	N/A
N/A	Any Obstructions?	N/A	N/A	Storm Grate/Utility Hazard?	N/A
	Obstruction Type			Storm Grate/Utility Type	
		N/A			N/A
		Yes		Surface Condition? (G/P)	Good

**Remove & Replace Curb Ramp With Two New Directional Ramps or Equivalent.**
