Access Compliance Report

Public Rights-of-Way

(Curb Ramps)

| Intersection ID: 44955 | Main Street: OAKTON_HUNT_DR | Cross Street: WEAVERS_GLENN_PL | Location: NE |

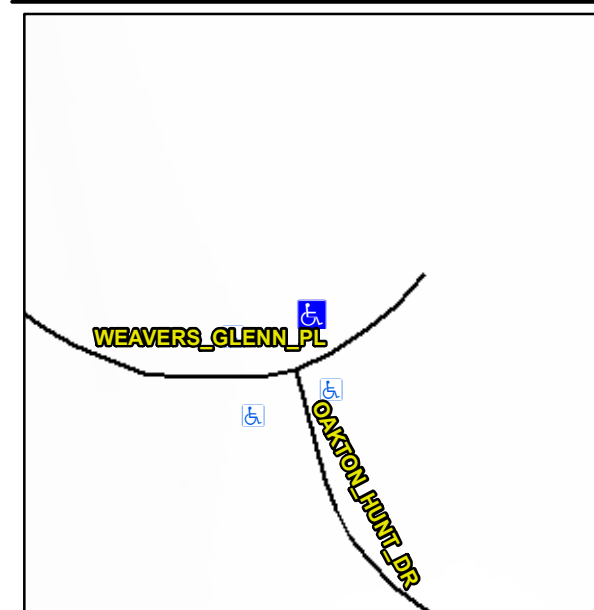
Not Found, R304.5.3

| Compliance | Description | Data | Compliance | Description | Data |
|---|---|---|---|---|---|
| N/A | Ramp Length (in) | 50.0 | Yes | Ramp Slope (%) | 7.3 |
| Yes | Ramp Width (in) | 49.0 | No | Ramp XSlope (%) | 5.1 |

Remove & Replace Entire Ramp.
