# Access Compliance Report

## Public Rights-of-Way

Intersection ID: 24180	Main Street: CANDLEWYCK_LN	Cross Street: STONERIDGE_RD	Location: NW
ADA ID: 4AA2FD9BA113	Ramp Type: PerpDiag	Initial Pass/Fail: Fail	Overall Compliance: No
Severity Score: 25			
Codes/Mitigation Info/Possible Solution		Field Measurements/Component Compliance

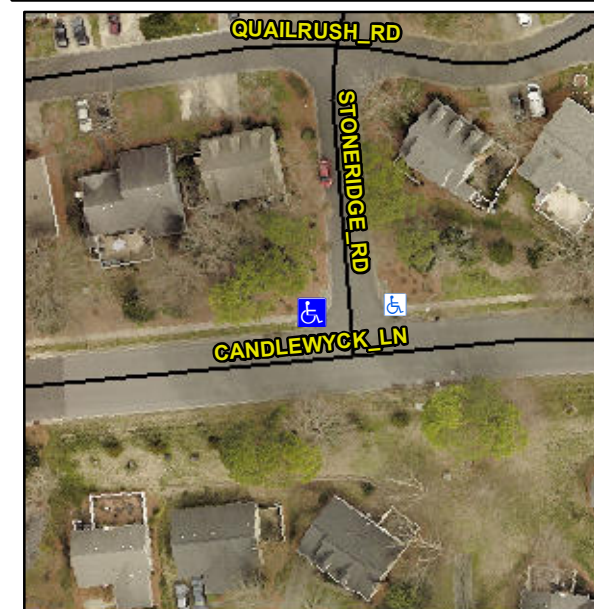
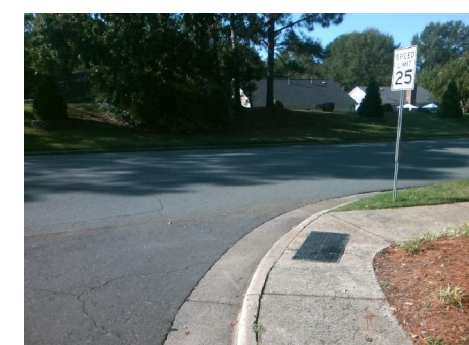
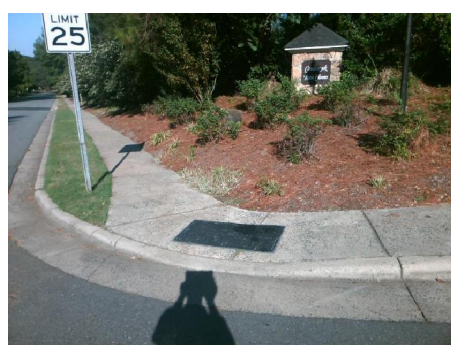
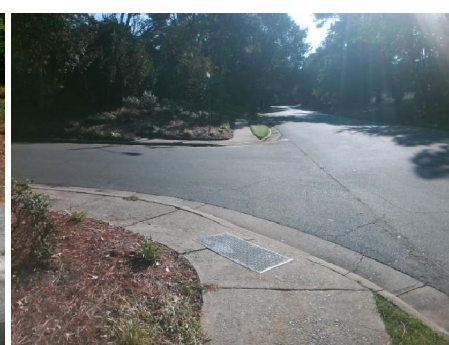
**R304.2.2, R304.5.3**

Compliance	Description	Data	Compliance	Description	Data
N/A	Ramp Length (in)	47.0	No	Ramp Slope (%)	10.3
Yes	Ramp Width (in)	48.0	No	Ramp XSlope (%)	5.1
N/A	Flare Type LT	N/A	N/A	Flare Type RT	N/A
N/A	Flare Slope LT (%)	N/A	N/A	Flare Slope RT (%)	N/A
N/A	Flare Traversable LT?	N/A	N/A	Flare Traversable RT?	N/A
N/A	Landing Length (in)	N/A	N/A	DWS Provided?	N/A
N/A	Landing Width (in)	N/A	N/A	DWS Contrast?	N/A
N/A	Landing Slope (%)	N/A	N/A	DWS Length (in)	N/A
N/A	Landing X Slope (%)	N/A	N/A	DWS Full Width?	N/A
N/A	Landing Curb? (Y/N)	N/A	N/A	DWS Offset (in)	N/A
N/A	Shared Landing?	N/A			
N/A	Gutter Ponding?	N/A	N/A	Gutter Slope (%)	N/A
N/A	Gutter Lip Ht (in)	N/A	N/A	Gutter X Slope (%)	N/A
N/A	Painted X Walk1?	No	N/A	Painted X Walk2?	No
	X Walk 1 Direction	To S		X Walk 2 Direction	To E
N/A	X Walk 1 Width (in)	N/A	N/A	X Walk 2 Width (in)	N/A
	X Walk 1 Slope (%)	3.9		X Walk 2 Slope (%)	3.1
	X Walk 1 X Slope (%)	2.5		X Walk 2 X Slope (%)	5.9

N/A	Ramp inside XWalk1?	N/A	N/A	Ramp inside XWalk2?	N/A
	Road Slope (%)	3.5	N/A	Clear Space?	N/A
	Road X Slope (%)	1.8	N/A	Clear Space to XWalk (in)	N/A
N/A	Any Obstructions?	N/A	N/A	Storm Grate/Utility Hazard?	N/A
	Obstruction Type			Storm Grate/Utility Type	
		N/A			N/A
		Yes		Surface Condition? (G/P)	Good

**Remove & Replace Curb Ramp With Two New Directional Ramps or Equivalent.**
