Access Compliance Report Public Rights-of-Way (Curb Ramps)

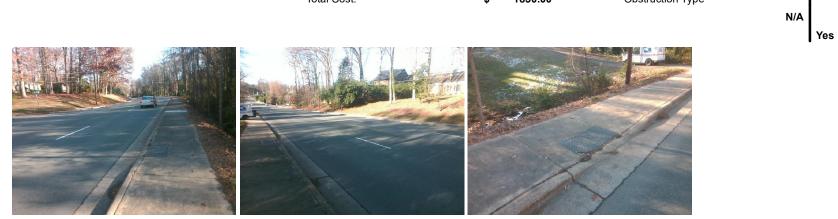
Intersection ID: 19036	rsection ID: 19036 Main Street: RANDOLPH RD				RANDSTONE_CT	Location:	NW			
ADA ID: 4AAD6A199B32 Ramp Type: Perp			Initial Pass/Fail: Fail Overall Compliance: No				Severity Score:	21.25		
Codes/Mitigation Info/Possible Solution				Field Measurements/Component Compliance						
	A Martin Co	Possible Solutions:	Compliance Description			Data	Data Compliance Description			
Cont 9		Remove & Replace Entire Ramp		N/A	Ramp Length (in)	68.0	Yes	Ramp Slope (%)	7.6	
	~			No	Ramp Width (in)	47.0	No	Ramp XSlope (%)	6.7	
	Call 1			N/A	Flare Type LT	N/A	N/A	Flare Type RT	N/A	
	A ST A			N/A	Flare Slope LT (%)	N/A	N/A	Flare Slope RT (%)	N/A	
A CONTRACTOR OF THE OWNER	ST AN			N/A	Flare Traversable LT?	N/A	N/A	Flare Traversable RT?	N/A	
	Con and a second			N/A	Landing Length (in)	N/A	N/A	DWS Provided?	N/A	
A CONTRACTOR OF A CONTRACTOR OFTA CONTRACTOR O	/	Surveyor Notes:		N/A	Landing Width (in)	N/A	N/A	DWS Contrast?	N/A
