| Intersection ID: N/A | Main Street: MONROE_RD | Cross Street: BRAMLET_RD | Location: | NW |
| ADA ID: 4AD8F6E3C497 | Ramp Type: PerpDiag | Initial Pass/Fail: Fail | Overall Compliance: No | Severity Score: 21.25 |

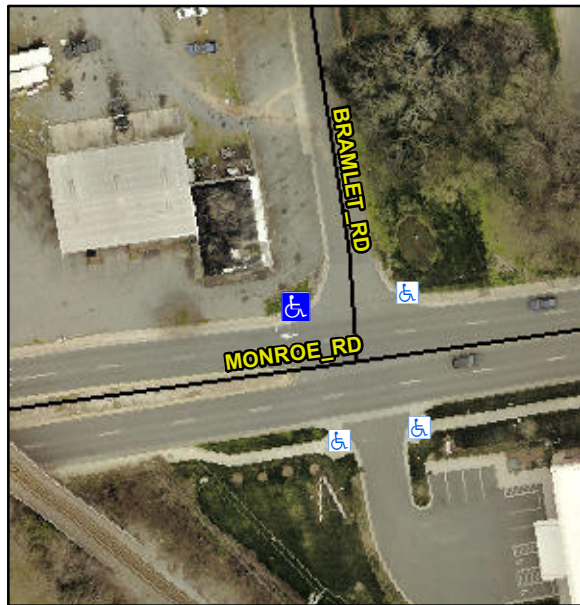
**Not Found, R304.5.1, R304.5.3**

| Compliance | Description | Data | Compliance | Description | Data |
|---|---|---|---|---|---|
| N/A | Ramp Length (in) | 56.0 | Yes | Ramp Slope (%) | 6.4 |
| No | Ramp Width (in) | 40.0 | No | Ramp XSlope (%) | 5.2 |

**Remove & Replace Curb Ramp With Two New Directional Ramps or Equivalent.**
