Access Compliance Report

Public Rights-of-Way

(Curb Ramps)

Intersection ID: 24097	Main Street: LIVINGSTON_MILL_RD	Cross Street: QUEENSWATER_LN	Location: NW
ADA ID: 4ADFFD4B973B	Ramp Type: Perp	Initial Pass/Fail: Fail	Overall Compliance: No
Severity Score: 21.25			
Codes/Mitigation Info/Possible Solution		Field Measurements/Component Compliance

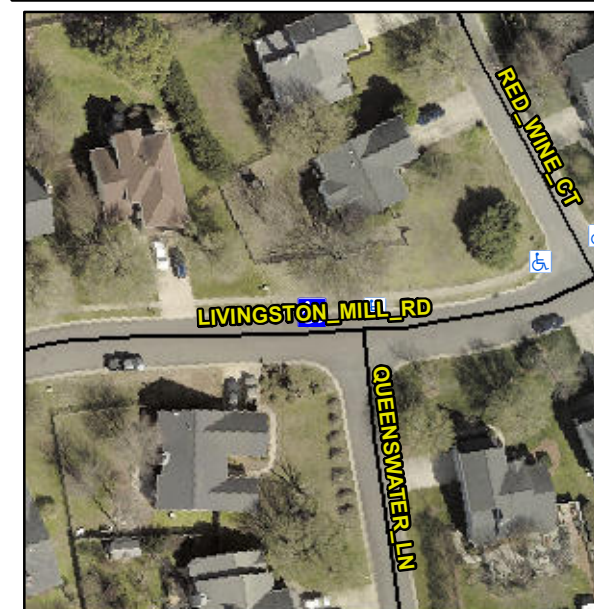
R304.5.1, R304.2.2

Compliance	Description	Data	Compliance	Description	Data
N/A	Ramp Length (in)	48.0	No	Ramp Slope (%)	8.7
No	Ramp Width (in)	47.0	Yes	Ramp XSlope (%)	1.1
N/A	Flare Type LT	N/A	N/A	Flare Type RT	N/A
N/A	Flare Slope LT (%)	N/A	N/A	Flare Slope RT (%)	N/A
N/A	Flare Traversable LT?	N/A	N/A	Flare Traversable RT?	N/A
N/A	Landing Length (in)	N/A	N/A	DWS Provided?	N/A
N/A	Landing Width (in)	N/A	N/A	DWS Contrast?	N/A
N/A	Landing Slope (%)	N/A	N/A	DWS Length (in)	N/A
N/A	Landing X Slope (%)	N/A	N/A	DWS Full Width?	N/A
N/A	Landing Curb? (Y/N)	N/A	N/A	DWS Offset (in)	N/A
N/A	Shared Landing?	N/A			
N/A	Gutter Ponding?	N/A	N/A	Gutter Slope (%)	N/A
N/A	Gutter Lip Ht (in)	N/A	N/A	Gutter X Slope (%)	N/A
N/A	Painted X Walk1?	No	N/A	Painted X Walk2?	N/A
	X Walk 1 Direction	To S		X Walk 2 Direction	N/A
N/A	X Walk 1 Width (in)	N/A	N/A	X Walk 2 Width (in)	N/A
	X Walk 1 Slope (%)	2.6		X Walk 2 Slope (%)	N/A
	X Walk 1 X Slope (%)	1.7		X Walk 2 X Slope (%)	N/A

N/A	Ramp inside XWalk1?	N/A	N/A	Ramp inside XWalk2?	N/A
	Road Slope (%)	N/A	N/A	Clear Space?	N/A
	Road X Slope (%)	N/A	N/A	Clear Space to XWalk (in)	N/A
N/A	Any Obstructions?	N/A	N/A	Storm Grate/Utility Hazard?	N/A
	Obstruction Type			Storm Grate/Utility Type	
		N/A			N/A
			Yes	Surface Condition? (G/P)	Good

Remove & Replace Entire Ramp.

Total Cost: \$ 1850.00
